# Protocols for the Assessment and Repair of Bridge Foundations

Final Report

August 2016  
FHWA HIF-17-044

U.S. Department of Transportation  
Federal Highway Administration

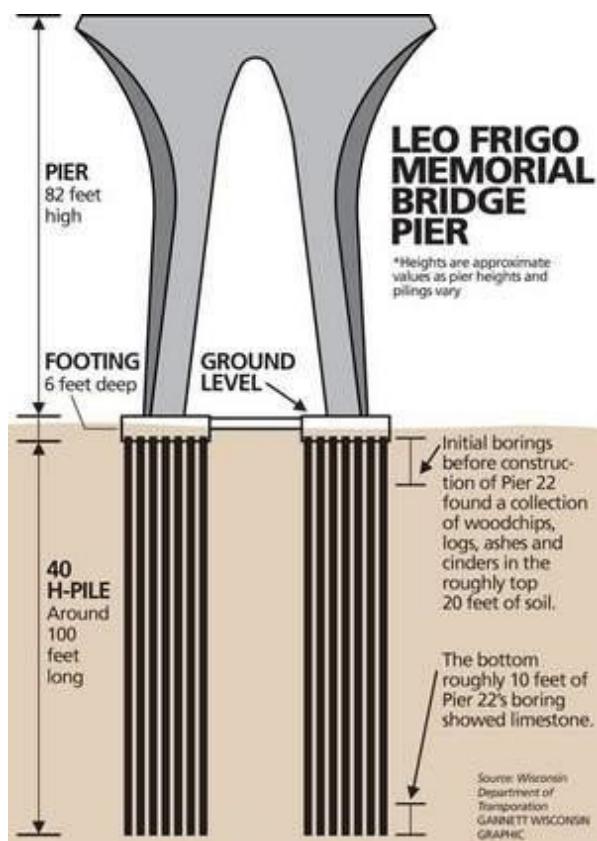
The Leo Frigo Memorial Bridge, part of Interstate 43, carries an average 40,000 vehicles per day over the Fox River in Green Bay, Wisconsin (Phelps, 2013). The 1.5-mile-long bridge consists of four lanes, two lanes carrying traffic in each direction. The tied-arch bridge was originally constructed in 1981, with 52 concrete piers each supported by 40 steel H-piles (WisDOT, 2015). Piles were driven approximately 100 feet deep, with the pile tips bearing either in limestone or the dense clay above rock. Subsurface conditions consisted of approximately 20 feet of fill, including porous fly ash fill and industrial byproducts, overlying layers of dense clay and sand with rock at a depth of approximately 90 to 120 feet, as shown in Figure A-1 (Williams, 2013). The bridge was inspected in October of 2012 and determined to be structurally sound (NACE International, n.d.).

Figure A-1: Existing Conditions of Leo Frigo Memorial Bridge (Williams, 2013)

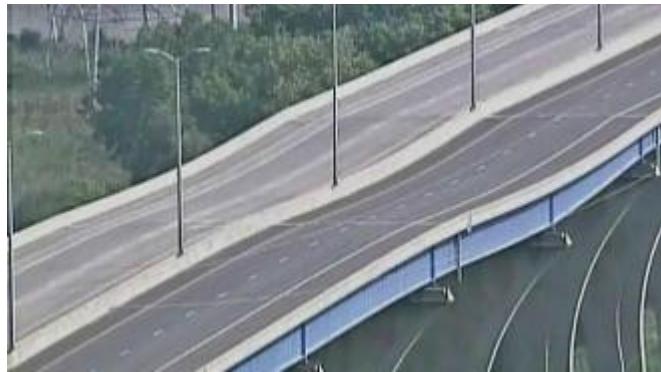
On September 25, 2013, Pier 22 suddenly settled approximately 2 feet between 3:00 and 3:45 AM. The bridge was closed after motorists called 911 early that morning to alert authorities about the resulting dip in the bridge deck. The vertical displacement of the 400-foot-long span of the bridge deck is shown in Figure A-2 (Phelps, 2013; WisDOT, 2015)

**Figure A-2: Sagging Leo Frigo Memorial Bridge (Thompson, 2013)**

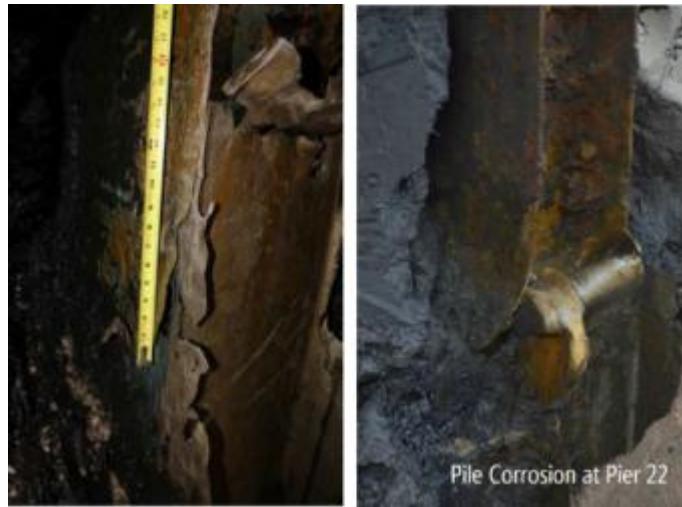
Subsurface explorations began on September 28 to investigate the cause of the sudden settlement. Robotic survey instrumentation was also installed to monitor any additional movement of the pier. Investigations revealed corrosion and subsequent buckling of the deteriorated steel H-piles supporting Pier 22 caused the observed settlement. Figure A-3 shows pile corrosion found under Pier 22. Pile corrosion was also found underneath Piers 21, 23, and 25. Investigations determined that the composition of industrial byproduct fill placed in the area of the corroded piles prior to construction interacting with groundwater led to accelerated steel pile corrosion. The porous fly ash fill had high levels of chlorides and sulfides and low resistivity, leading to increased corrosion. A clay layer underlying the fill also led to high differential oxygen levels and chemical concentrations, providing a corrosive environment. Microbial activity also likely played a role in increasing corrosivity. The problem was not detected earlier as checking for pile corrosion is not part of regular bridge inspections. (Phelps, 2013; WisDOT, 2015)

**Figure A-3: Pile Corrosion at Pier 22 (Source: Wisconsin DOT)**

All piers for the Leo Frigo Memorial Bridge were assessed for pile corrosion and grouped into three categories: tier 1, tier 2, and tier 3. Tier 1 piers showed severe pile corrosion and needed immediate repairs. Tier 2 piers showed some corrosion or potential corrosion, but were not an immediate safety concern. Further monitoring of tier 2 piers was recommended. Tier 3 piers did not show any pile corrosion and had very low potential for future pile corrosion. Piers 21, 22, 23 and 25 were identified as tier 1. Pier 24 was also identified as tier 1 due to its close proximity to other tier 1 piers, even though corrosion was not as severe at Pier 24. Seventeen piers were identified as tier 2. Monitoring instruments were installed on these piers and treatment options were identified should corrosion occur faster than anticipated. No action was required for the tier 3 piers. (WisDOT, 2015)

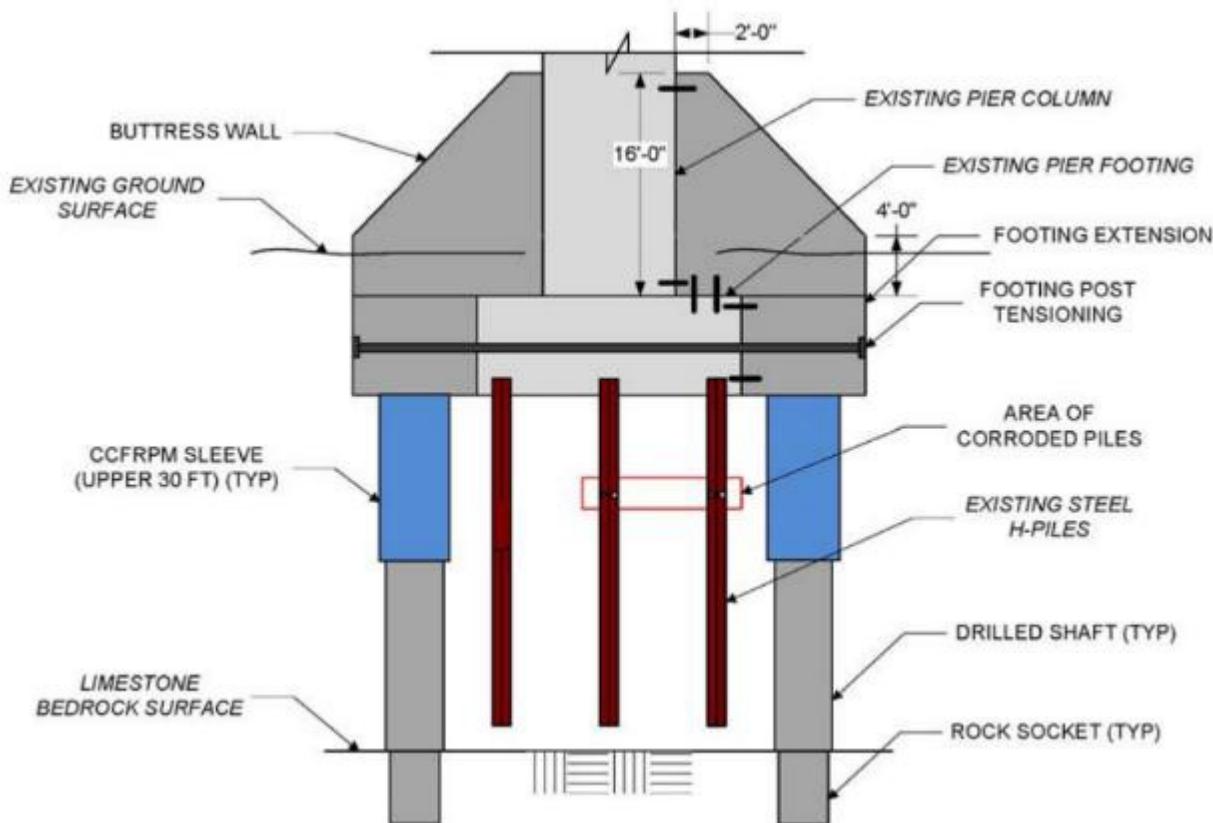
Figure A-4: Schematic of Repairs for Piers 21-25 (Source: Wisconsin DOT)

Repairs were completed and the bridge was re-opened in January 2014, just three months after the initial closing. Round-the-clock investigations and construction led to an ahead of schedule, under budget, and successful repair. The restoration of the Leo Frigo Bridge won an Engineering Excellence award from ASCE Wisconsin, recognizing the dedication of the project team and success of the repairs. Repairs cost \$8.45 million, including a \$750,000 bonus for finishing early. Costs were completely covered by federal emergency funding. (WisDOT, 2015; Michael Baker Jr. Inc., 2014)

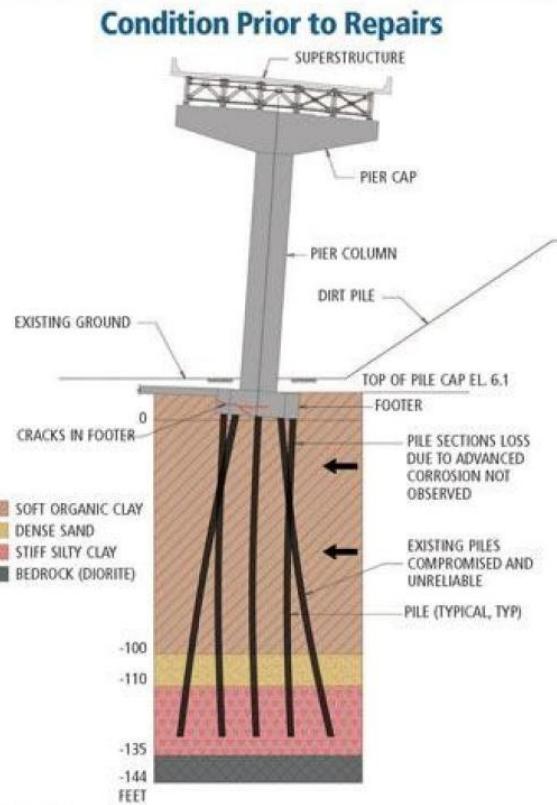
**Figure A-5: Subsurface Profile and Observed Damage at I-495 Bridge (O'Shea, 2015)**

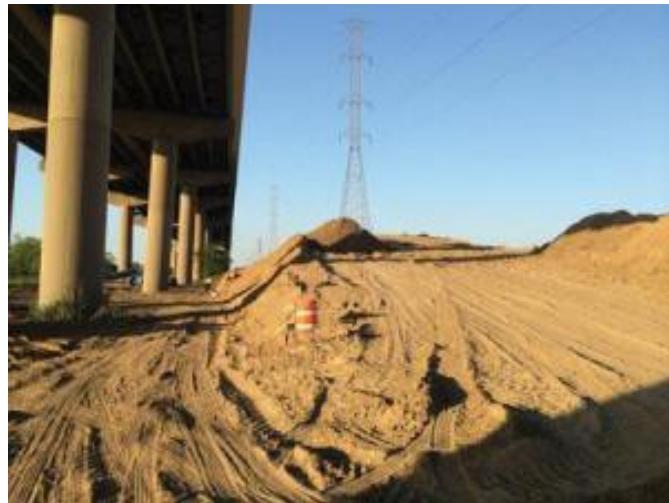
The bridge was closed on June 2, 2014 after it was observed that 60-foot-high piers on the northbound side were tilting toward the east (Moffitt and Shelly, 2015). The damage was observed by a geotechnical engineer who was working for a third party and was on site to investigate whether a soil stockpile on adjacent private property had caused damage to an underground petroleum pipeline. The stockpile was adjacent to the northbound side of the interstate, specifically in the area of bridge piers 11 through 14. These piers were tilted as much as four percent out of the vertical alignment, resulting in an 18-inch difference in elevation between the median barriers. Subsequent investigations found that the stockpile had caused the bridge foundation failure by inducing lateral loads and deformations (lateral squeeze) into the thick soft clay layer, resulting in lateral displacements of the piles of up to two feet. Figure A-6 shows the soil stockpile adjacent to tilting piers. (Mohammad and Armfield, 2015; Burke and Montgomery, 2014)

Figure A-6: Tilting bridge piers and adjacent soil stockpile (O'Shea, 2015)

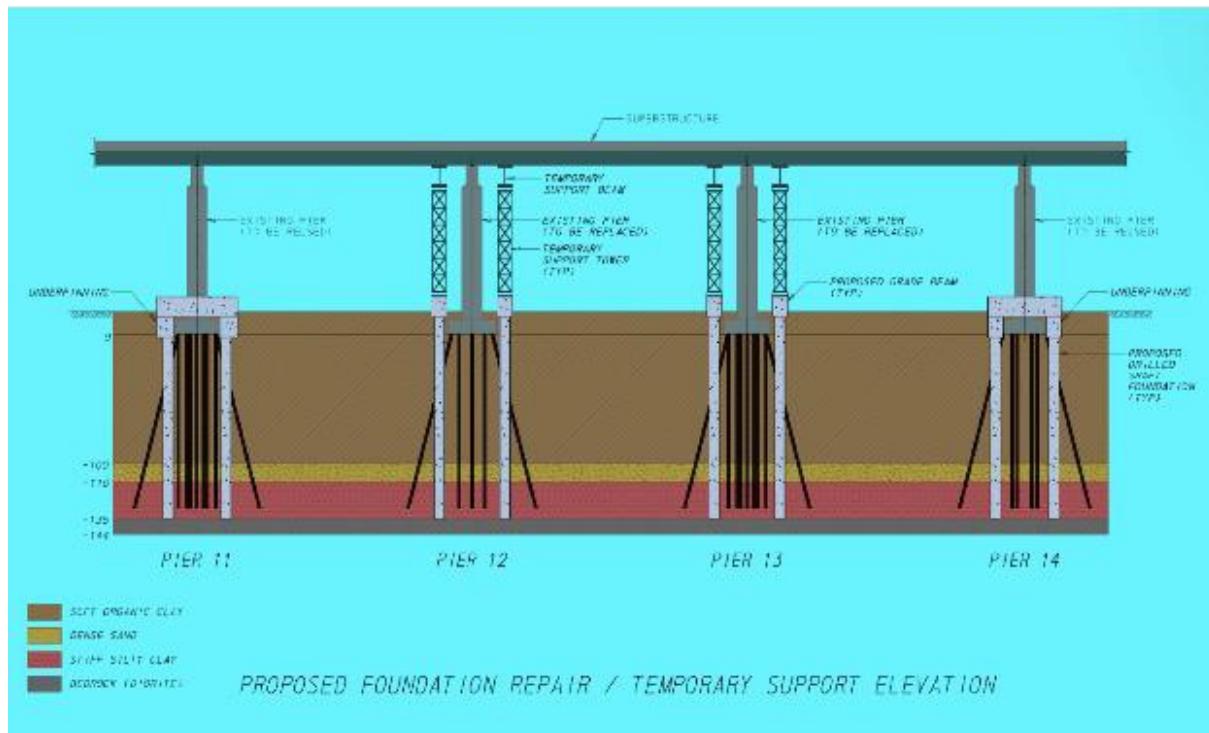
**Figure A-7: Repair methods and temporary support (Mohammad and Armfield, 2015)**

The southbound lanes of the bridge were opened within 59 days of closure and the northbound lanes were opened 83 days after closure. The total cost of repairs was \$40 million. Temporary repairs were paid completely by Federal funding and 90% of permanent repairs were paid for by Federal funding (O'Shea, 2015). Work was done 24/7 to complete repairs in a timely manner. Investigations and initial design were able to occur simultaneously, also saving time and money (Moffitt and Shelly, 2015). Close communication and cooperation of the client, designer, and contractor, along with the clear vision and leadership of DelDOT and assistance from FHWA, led to quick and successful repairs (Mohammad and Armfield, 2015).

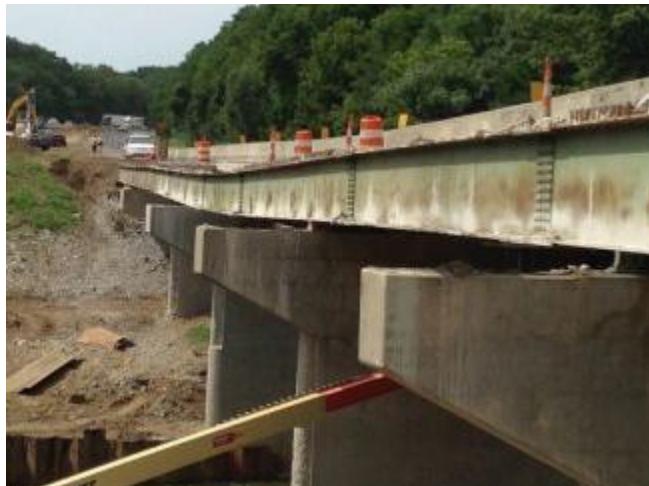
**Figure A-8: Post-Failure View, I-65 Bridge, Lafayette, Indiana (McCoy, 2015)**

A fracture critical inspection was performed prior to re-opening the bridge. Load tests were also performed, 24 hours after re-establishment of the final elevations. Load tests were performed with varying configurations of truck traffic on the bridge, to observe performance under maximum vertical load, negative moment on the superstructure, braking loads, and an eccentric loading on the restored pier and foundation. The bridge was instrumented with inclinometers and strain gages to observe performance during the load test program. The design-build bridge engineer, in their role as engineer-of-record, reviewed the design considerations associated with leaving the tilt in the existing pier, and confirmed its acceptability. The bridge reopened September 6, 2015, only a month after observed settlement. Continuous work by Indiana DOT and the contractor made the quick turnaround possible (INDOT, 2015). Construction of the remaining portion of the widening project progressed with continuous bridge monitoring by Purdue University, and with design and construction measures to avoid similar settlement of the remaining piers to be widened.

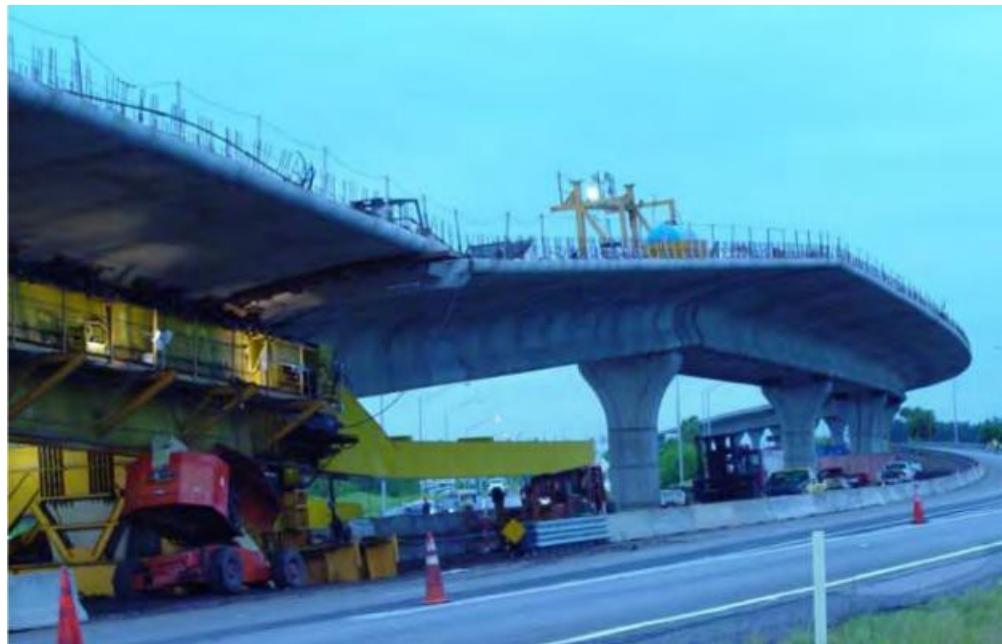
In April 2004, approximately 14 months into construction of the elevated lanes, Pier 97 suddenly settled 11 feet (Samuel, 2009). The photograph in Figure A-10 shows the damage from the sudden settlement.

Figure A-10: Collapse of Pier 97 in April, 2004 (Graham et al., 2014)

The 11 feet of settlement was initially thought to be due to an undetected sinkhole beneath Pier 97. However, a few months later in June, 2004, another pier settled a few inches. As more piers began to settle, further investigations found that only 50 of the 204 piers were designed with adequate foundations for the soil/rock strengths present. (Samuel, 2009; Graham et al., 2014).

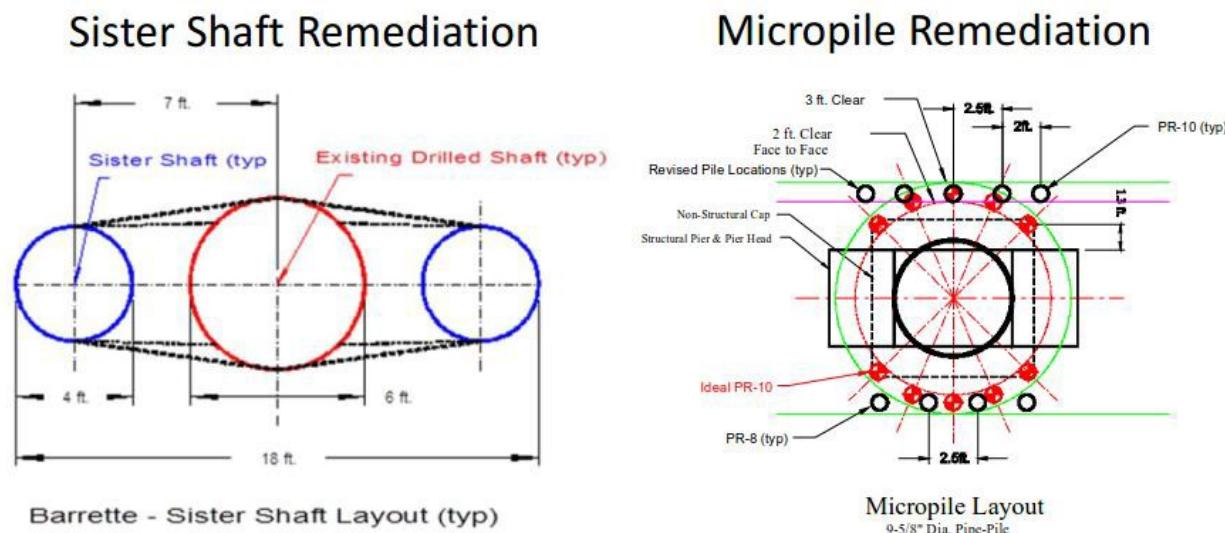
Figure A-11: Remediation techniques selected (Dapp et al., 2013)

Repairs were paid for by the owner, Tampa Hillsboro (Toll) Expressway Authority (THEA), but subsequently were the subject of a claim by THEA for recovery of these costs. Specific information about procurement of the repair work was not found in reviewed literature. Depending on geological conditions, the insufficient piers were either retrofitted with micropiles or drilled shafts. Four to ten micropiles, depending on soil conditions, were installed to augment existing foundations at 87 of the piers. Two 4-foot diameter "sister" drilled shafts were installed for support at each of the remaining 67 drilled shafts that needed remediation. Post-tensioned foundation caps were used to connect the existing foundation with the new drilled shafts. Figure A-11 shows schematics of the two different types of remediation. Multiple borings at each pier were taken and correlated to results from full scale dynamic testing previously done for recently constructed piers to determine if/how much additional support was needed (Samuel, 2009; Graham et al., 2014).

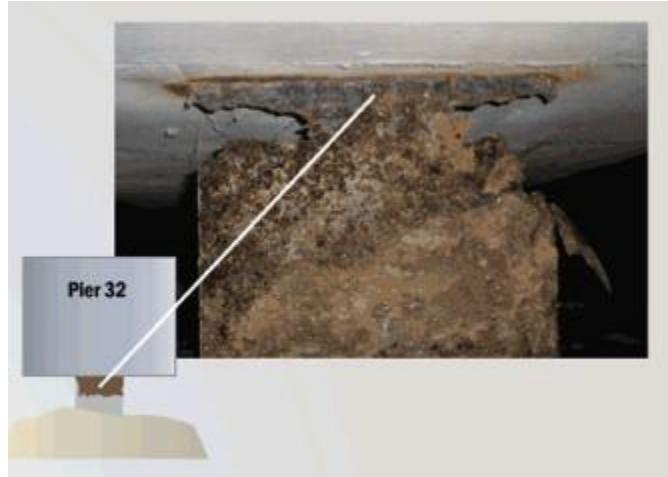
**Figure A-14: Pile corrosion under Pier 32 (Paint Square, 2013)**

MnDOT started repair work with its internal maintenance crew before hiring a contractor to complete the work. MnDOT awarded an emergency contract with an accelerated schedule for 24/7 work. Concrete collars were installed around the damaged piles at Pier 32 and the bridge was reopened about a month later. (Kraker, 2013; Paint Square, 2013)

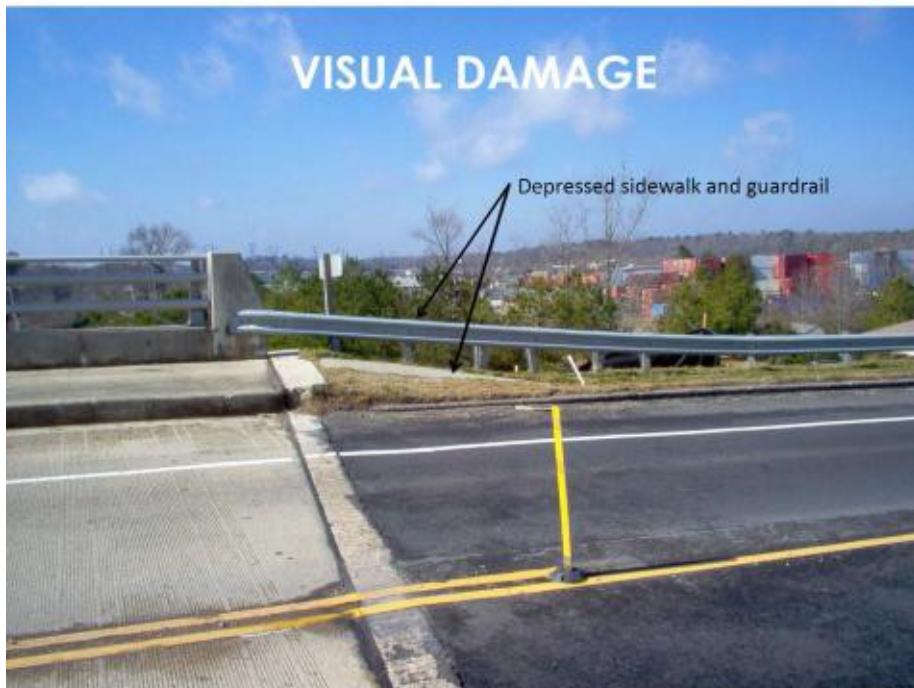
Settlements of 2.5 feet to 3.5 feet were expected from approach embankment loading during the original construction of the bridge. Since eighty percent of this settlement was expected to occur over 3 months, so the embankments were constructed and allowed to settle for 3 months before bridge construction began. However, by 2000, additional settlements of up to 2.5 to 3 feet had occurred at the approach embankments after the end of the bridge construction. Figure A-16 shows sagging of the approach at the surface from excessive embankment settlements. A study conducted in 2003 concluded that original analyses did not properly calculate anticipated settlements or account for downdrag effects on the foundation piles. Up to 22 more inches of consolidation of the soft clay layer under the existing embankment load was possible. Damage to the bridge from settlement included cracked beams, buckling of slope protection, and cracked wing walls. Investigation into the abutment foundations indicated that the piles supporting the abutment were severely damaged. Figure A-17 shows the tensile failure of a pile due to downdrag and the void beneath the abutment foundation. (DeStephen, 2015)

Figure A-16: Damage from Settlements (DeStephen, 2015)

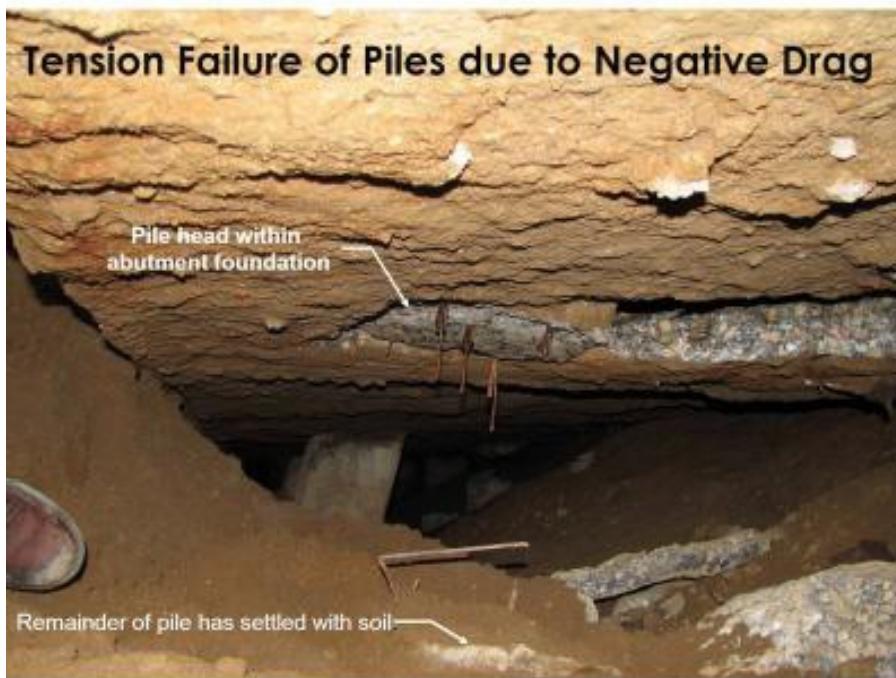
Figure A-17: Settlement Damage from Downdrag (DeStephen, 2015)

As of 2003, the center pier piles had settled up to 1.5 inches, the end pier piles had settled up to 3.5 inches, and the abutment piles settled from 4 to 12 inches. Repair alternatives considered included underpinning with micropiles, underpinning using jet grouting, or partial reconstruction of the bridge. No information on procurement of repairs was found in the reviewed literature. It

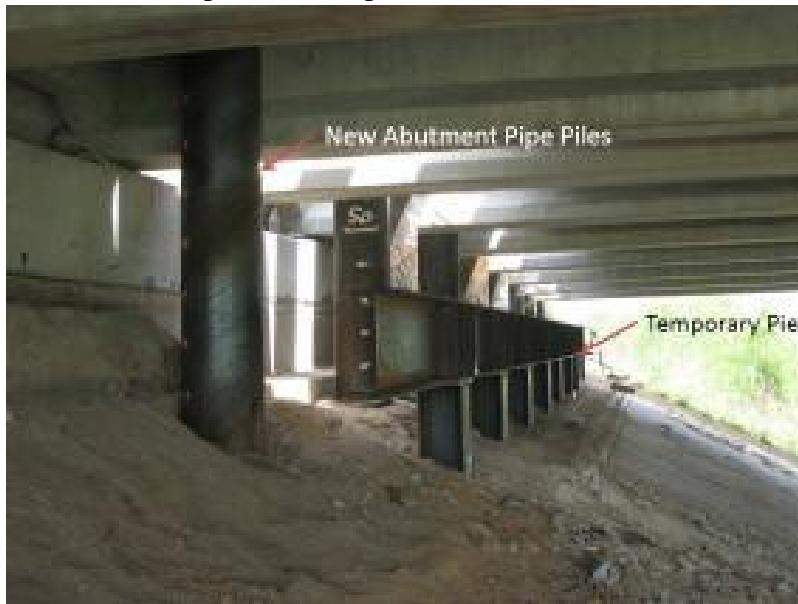
Figure A-18: Repairs and New Foundations (DeStephen, 2015)

was decided to reconstruct the bridge abutments while the piers and bridge spans were left in place. Sixteen-inch diameter steel pipe piles were installed as new foundations for the abutments. The piles were coated to reduce friction. Temporary shoring and steel H-piles were used to support the structure during abutment reconstruction. Square access holes were cut in the bridge deck to install the piles. Figure A-18 shows the temporary and permanent foundation elements replacing the original pre-stressed concrete piles. (DeStephen, 2015)

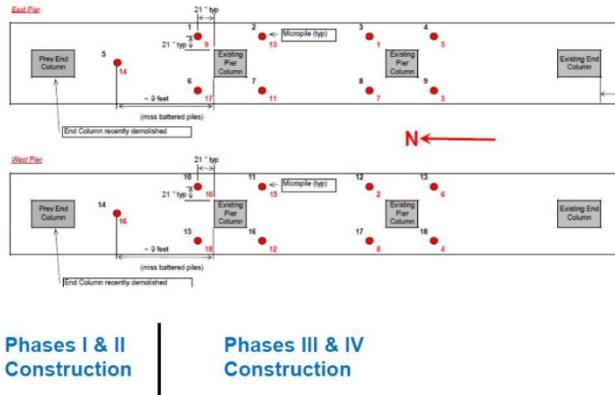
Figure A-20: Micropile Layout Plan (Thelen and Thome, 2011)

Overall, the emergency repairs included the following elements:
