PERFORMANCE OF HIGHWAY BRIDGE ABUTMENTS ON SPREAD FOOTINGS

Report No.
FHWA/RD-81/184

Final Report
October 1982

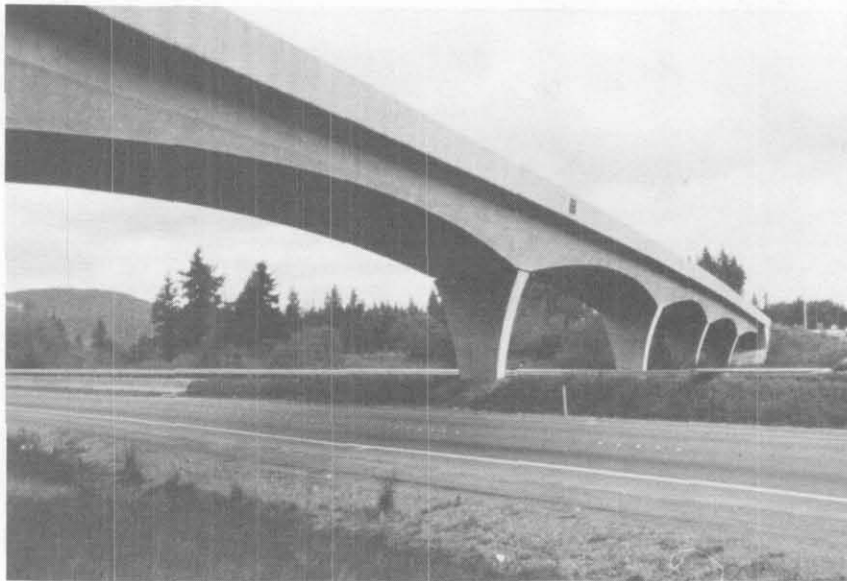
Figure 13. Evergreen Parkway Under-crossing

The abutment on fill has settled almost 2 inches (50 mm) differentially from the adjacent pier on piles. There are no signs of distress anywhere. The structure is in excellent condition.

Figure 14. Evergreen Parkway Pier #2 and Underside of Box Girder

Figure 15. Abutment No. 1 of Evergreen Parkway Structure

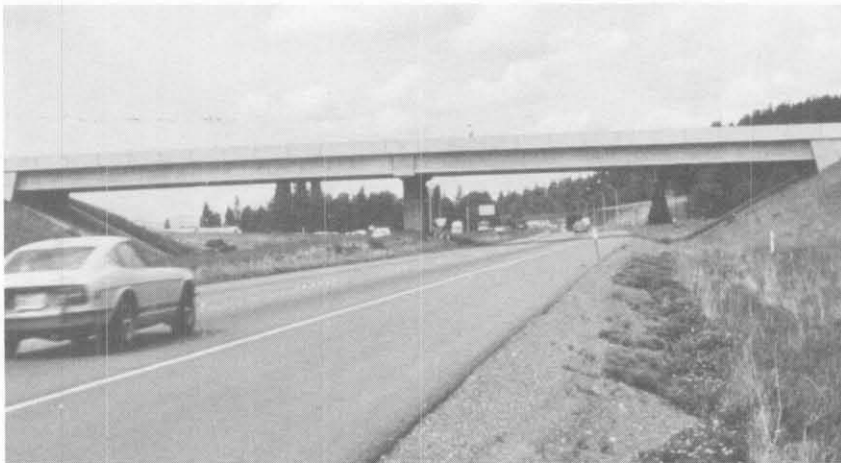
Figure 16. Anderson Road over Interstate 5

This bridge is in very good condition. There were no bumps at the bridge ends; but there were 15-20 foot (4.6-6.1 m) pavement patches at both ends. The bridge deck, curbing and barrier walls had minor cracks; however, the reason for the cracks was unknown.

Figure 17. Pier No. 2 and Concrete Girders of Anderson Road Overpass

Figure 18. Closeup View of Pier No. 2 of Anderson Road Overpass

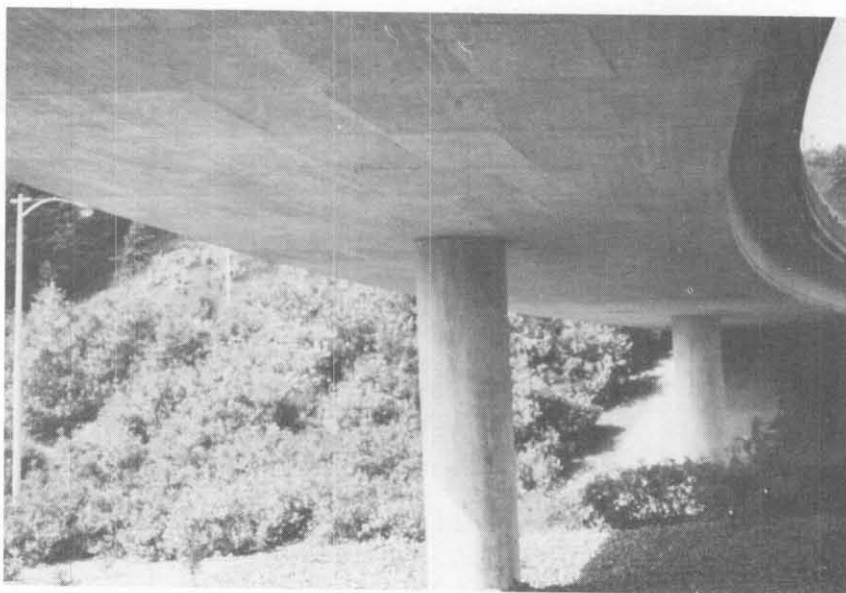
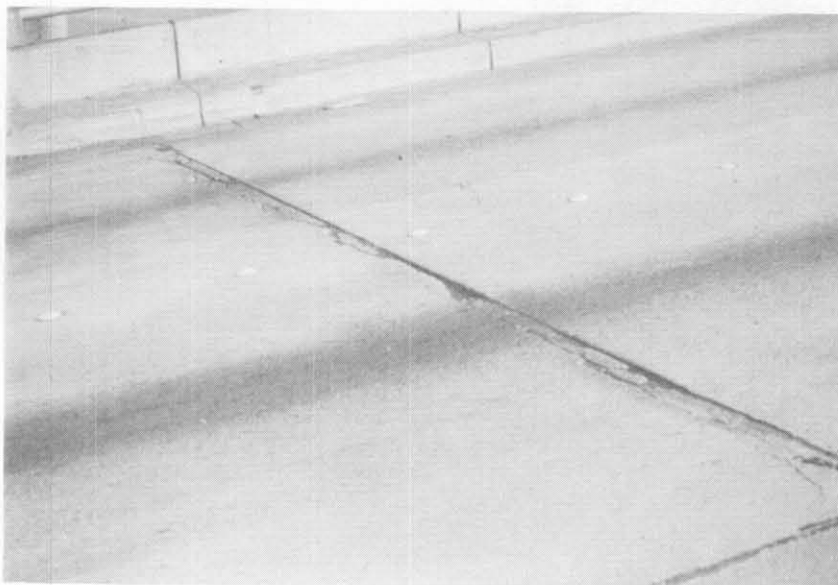
Figure 19. AR 19 Ramp in Pacific Avenue Interchange

This bridge is also in good condition. There is a slight bump at pier 5 (abutment on fill), but no patching has yet been done. Minor spalling and cracking has occurred in the deck and in some girders, and there is a 1 inch (25 mm) displacement between the bridge deck and fill curbs near pier 5.

Figure 20. Underside of Concrete Box Girder Bridge (AR 19 Ramp)

Figure 21. Bridge Approach Pavement for AR 19 Ramp

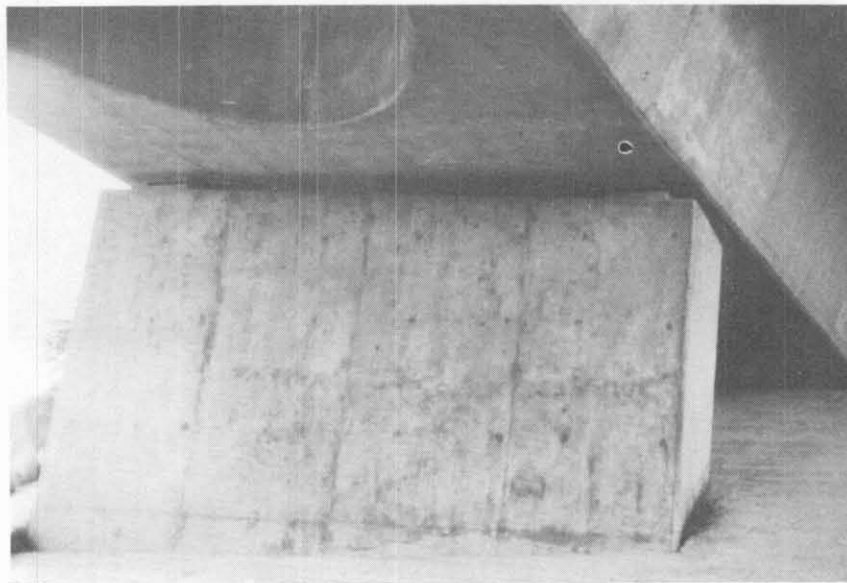
Figure 22. BL Ramp in Nalley Valley Interchange

The bridge is in good condition. There are neither bumps, patches, nor signs of distress. There is some deck cracking, but it does not seem to come from differential settlement.

Figure 23. Underside View of BL Ramp

Figure 24. Abutment of BL Ramp

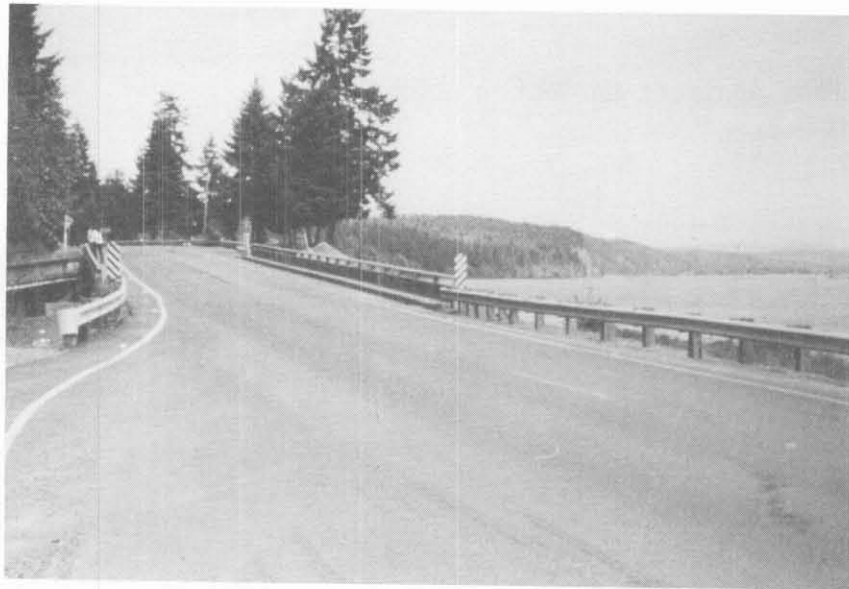
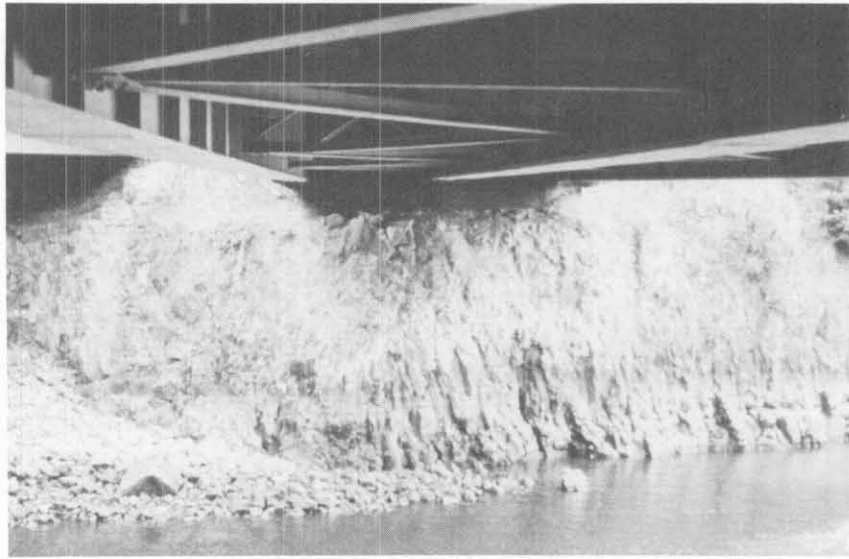
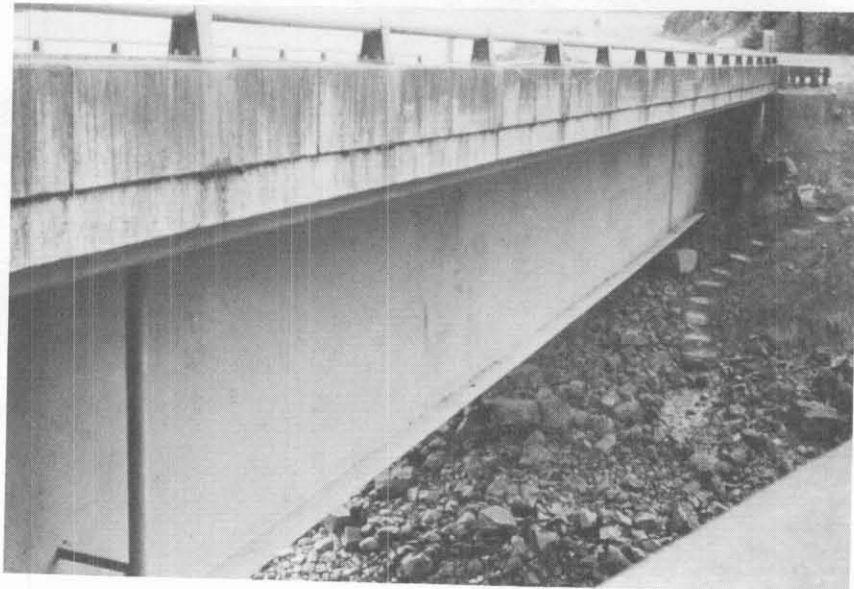
Figure 25. Mill Creek Bridge on SR 4

The abutment on fill continued to settle after construction and has settled 15 inches (0.4 m); but the bridge is in very good condition. There are no bumps at either end, and deck cracking is minimal. Each corner of the bridge has very slight vertical and lateral displacements. The most significant sign of distress is that bearing rockers at the fill abutment are tipped slightly inward.

Figure 26. East Abutment on Rock

Figure 27. West Abutment on Fill

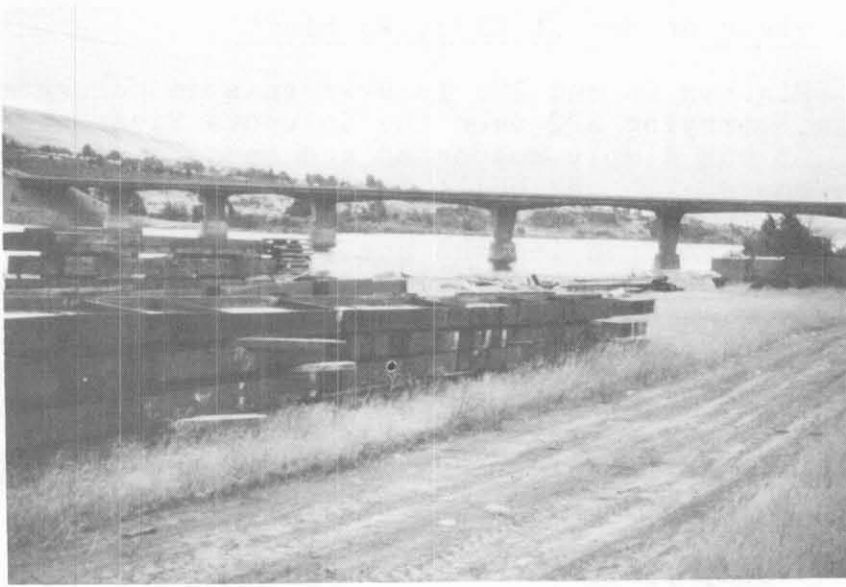
Figure 28. Columbia River Bridge at Olds, Washington

The bridge is in very good condition. There are neither bumps, patches, nor signs of serious distress. The inspection report shows only one hairline crack in the bottom flange of one girder.

Figure 29. Underside of Concrete Box Girder and Piers of Columbia River Bridge

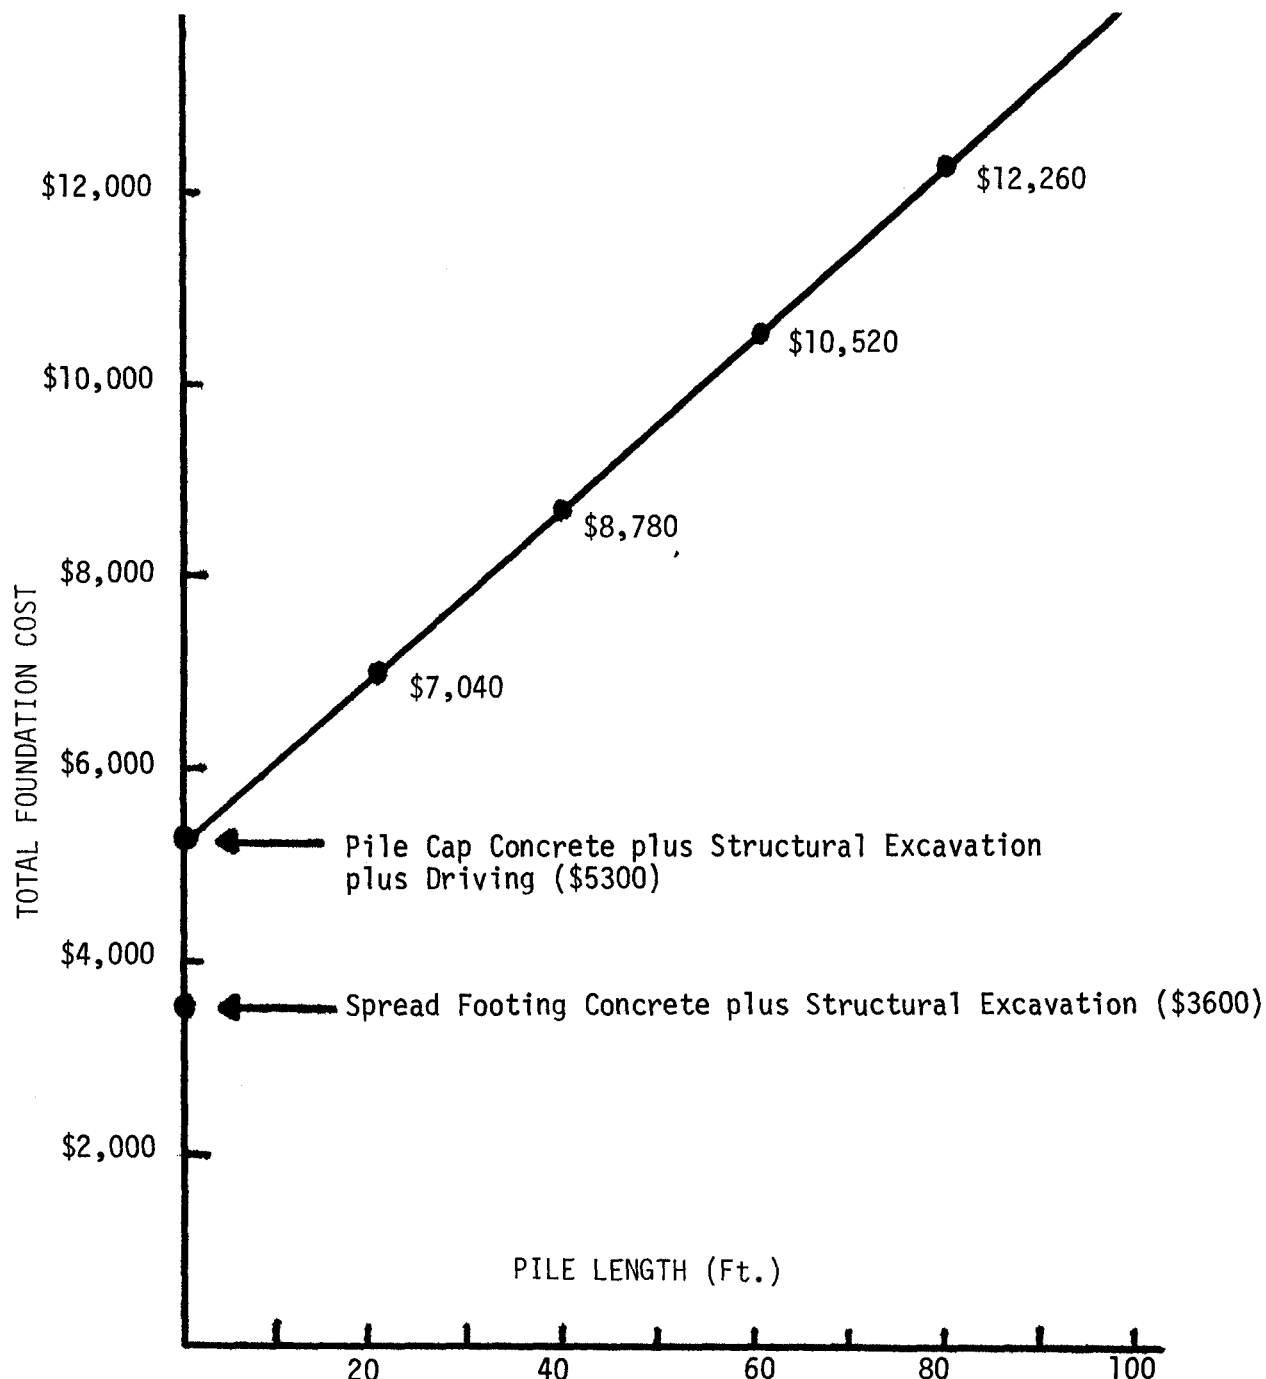
Figure 34. Pile Lengths versus Total Foundation Cost for one abutment

The actual savings will vary with the length of piles furnished. The size of the spread footing and pile cap, and the number of piles will remain unchanged for this project, but the pile lengths will vary with driving resistance. Figure 34 shows the effect that pile lengths have on the cost comparison of spread footings and piles.
