Foundation Reuse for Highway Bridges

Report No. FHWA-HIF-18-055	2. Government Accession No.:	3. Recipient's Catalog No.	
4. Title and Subtitle: Foundation Reuse for Highway Bridges		5. Report Date: November 2018

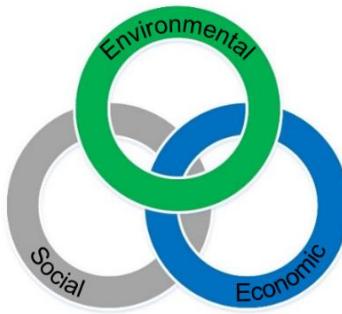
Figure 3. Diagram. Three drivers for foundation reuse (Adapted from FHWA INVEST website)

Reuse of bridge foundations potentially offers numerous economic, environmental, and social benefits that can drive the decision-making process. In many cases, competing replacement/reuse alternatives may offer various benefits that may be difficult to objectively compare and quantify. To have a better understanding of the advantages of foundation reuse, the underlying drivers can be lumped into three categories: economic, environmental, and social. These three categories form the “triple bottom line” of sustainability described by the INVEST program (FHWA 2017), as shown in figure 3. The individual benefits derived from foundation reuse can impact one or more of these categories.

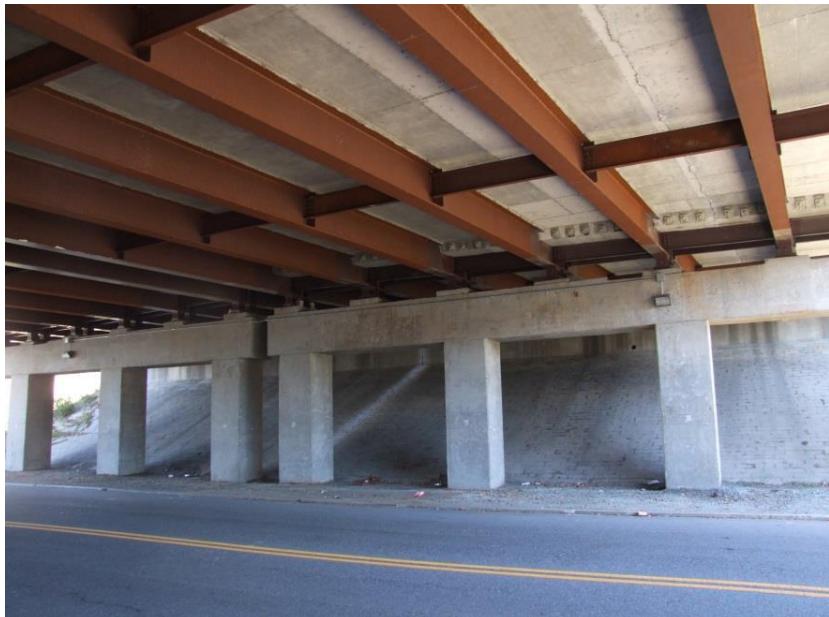
Figure 6. Photo. I-95 Bridge over Overbrook Road Showing Underside after renovation

In all, 2 of the 11 bridges exceeded this threshold and required ECE. Patching of spalls and cathodic protection with an aluminum-zinc-indium galvanic anode was applied to all nine bridges that did not require ECE. To help evaluate the effectiveness of the combination of ECE and cathodic protection over time, cathodic protection was not applied to one of the two bridges where ECE was performed. Overall, it was expected that ECE alone would extend the usable life of the substructures by 15 to 20 years. ECE, sealers, expansion joint changes, and cathodic protection could extend the usable life of the piers significantly longer (Sharp 2016). A photo of the repaired foundation with a replacement superstructure is provided in figure 6.

In general, the substructures were found to be in relatively good condition, although almost all of them had undergone at least some chloride-related corrosion. The main source of damage was chloride intrusion, which had led to reinforcement corrosion, cracking, and spalling. VDOT established a criterion to replace an element when the cost of all required repair, electrochemical extraction (ECE), sealer, and cathodic protection exceeded 40 percent of the replacement cost of the element. A threshold of 0.08 percent chloride content by weight at the reinforcement level was established. Elements with a higher chloride content than 0.08 percent were deemed to require ECE in addition to cathodic protection and sealer.

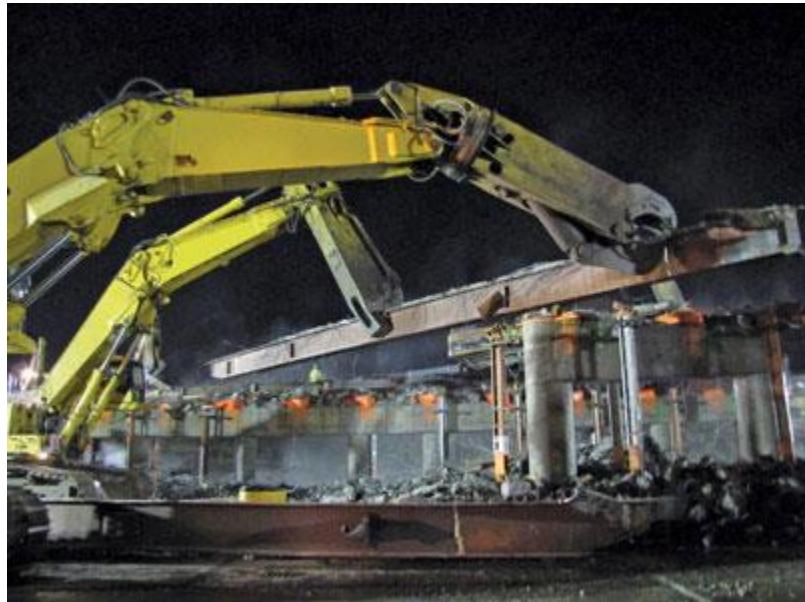
Figure 7. Photo. Demolition stage for removing the existing girders

and diverted over to one side of the highway while the bridges on the opposing side were replaced. All 14 bridges were eventually replaced in a total of 10 weekend diversions, without any complete closure of the highway traffic. The replacement bridge decks consisted of steel girders with composite concrete decks that were prefabricated off-site and moved into place. Aside from normal deterioration, the substructures were considered to be in “salvageable” condition (Moran 2012). MassDOT opted to repair the observed deterioration and reuse the substructures as is. Changes were made to the expansion joints of the bridge to prevent water seepage that had caused damage to the original decks and substructures. A photo of demolition of one of the original bridge decks is provided in figure 7.

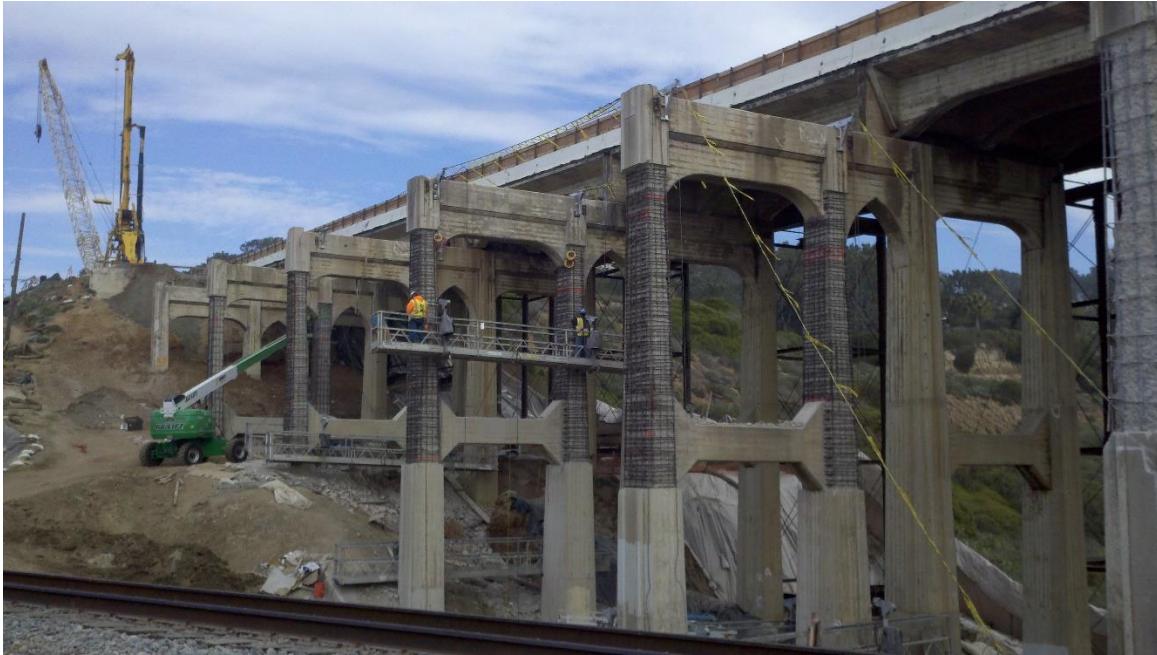
spreading, excessive shear and moment in pier columns, and excessive displacement demand in some of the columns. A significant retrofit program was undertaken to correct these issues, as shown in figure 11.

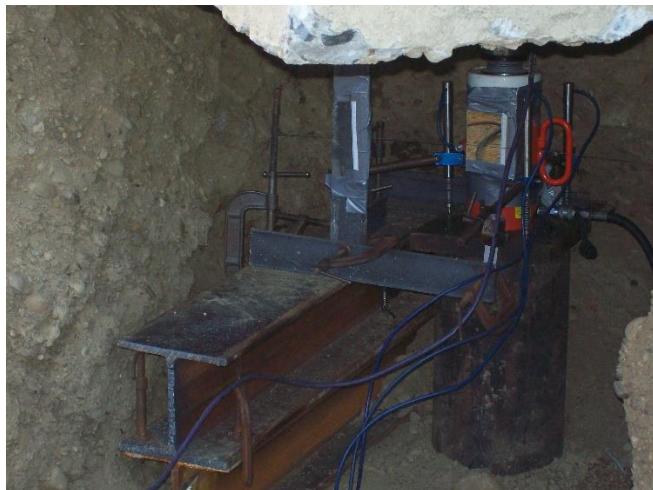
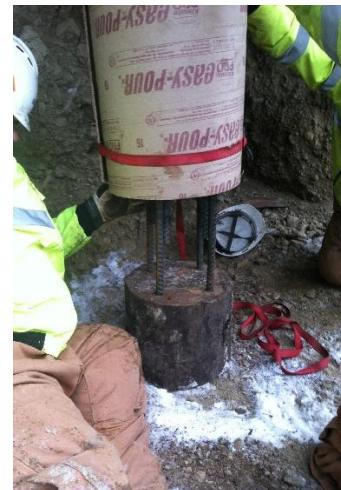
The Haynesville Bridge carries U.S. Route 2A over the Mattawamkeag River in Haynesville, Maine. The bridge is a 3-span steel girder bridge with two mass concrete stub abutments on treated timber piles and two solid wall piers on untreated timber piles. MaineDOT decided to replace the superstructure while reusing the substructures and pile foundations without modification. The piles were reused after a static load test was performed under each abutment. A resistance factor of 0.7 was applied to the nominal capacity of piles under the tested abutments, and 0.65 to all piles beneath the untested pier abutments, which is consistent with LRFD criteria. Figure 15 shows static load testing with a hydraulic jack after excavation of a pile cap and cutting of one of the timber piles.

A. Load test setup for north abutment

B. Repairing of a test pile with concrete

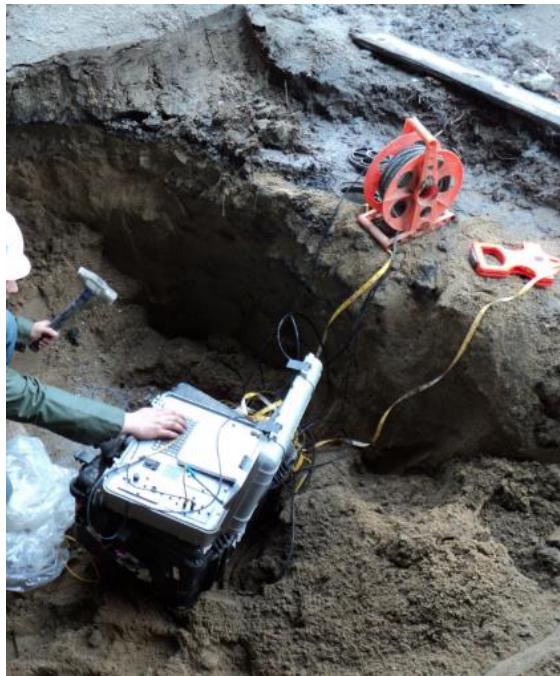
**Figure 17. Photo. Parallel Seismic (PS) setup for abutment of U.S. Route 1 Bridge in Maine
Mississagi River Bridge Rehabilitation and Deck Replacement, Ontario, Canada**

In the bridge, 11 out of 19 piers and 1 of the abutments were supported by steel H-piles driven to bedrock. The other eight piers and remaining abutment were supported by spread footings on bedrock. The preliminarily estimated pile loads exceeded the factored axial resistance for most pier locations. Hence, the addition of micropiles was recommended. However, the final design of the bridge rehabilitation resulted in reduced loading that did not exceed the capacity of the H-piles. The bearing capacity of the piles was determined from subsurface investigation, review of as-built plans, and original construction logs. The consulting engineer recommended the structural resistance of the H-piles to be calculated with a reduced cross-section to account for potential corrosion during the intended 75-year service life extension. Parallel seismic nondestructive testing from a nearby borehole confirmed that the piles were approximately as deep as the bedrock, thereby providing confidence the piles had been driven to practical refusal on bedrock. Figure 17 illustrates the parallel seismic testing set up at the bridge site.

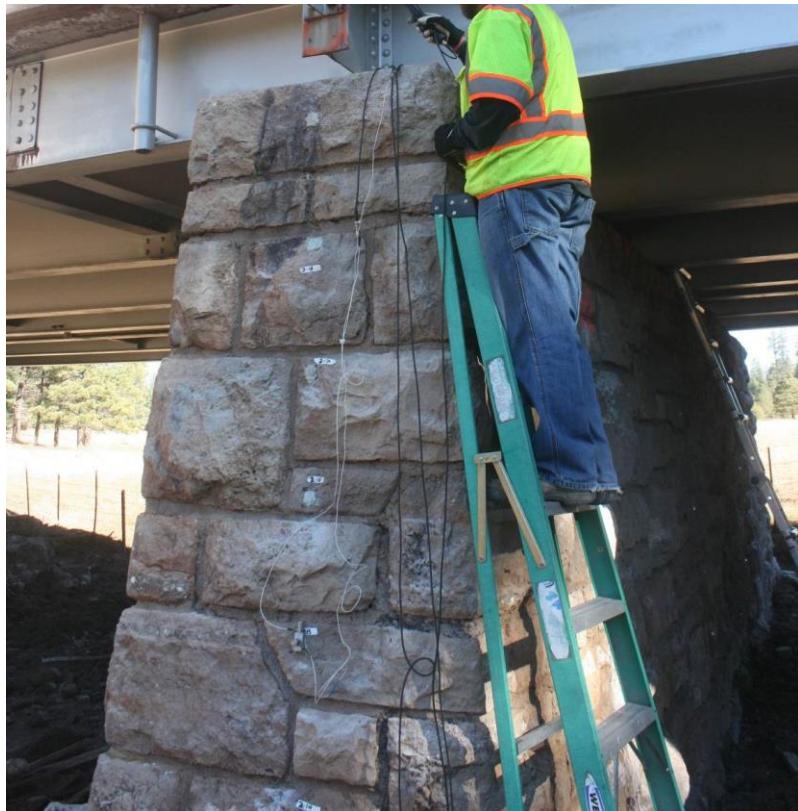
Figure 37 shows a technician performing ultrasonic (US) testing on one of the masonry piers by striking the top of the pier with a hammer while accelerometers are connected to the side of the pier. Figure 38 shows the drilling of a corehole being performed from the bridge deck, while only a single driving lane is closed.

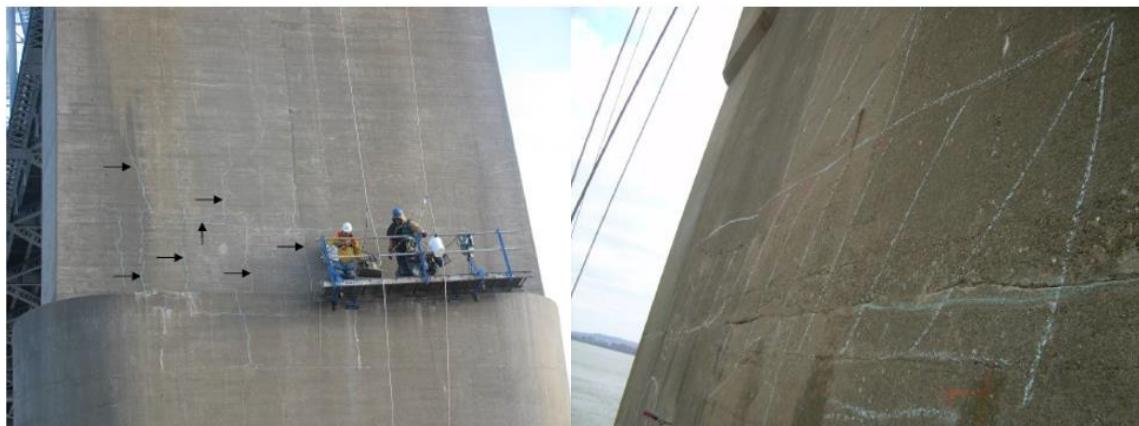
The initial condition assessment found horizontal cracking, vertical cracking, and lift lines in the piers being investigated for reuse. Varying amounts of spalling were observed, and zones of delaminated cover concrete were identified through hammer sounding. During this evaluation, six 4-inch (100 mm) diameter cores were taken for compression testing from the face of four piers, including three of the four piers eventually reused. An additional eight cores from the faces of the piers were taken for petrographic analysis. Petrographic analysis was also performed on seven cores taken vertically from the pier. The cores were drilled from the bridge deck ledges in the substructure. Logging of the vertically drilled cores was not performed. GPR and IR were performed to determine the location of reinforcement, cracking and delaminations. Pictures taken of the conditions at time of testing are provided in figure 39.

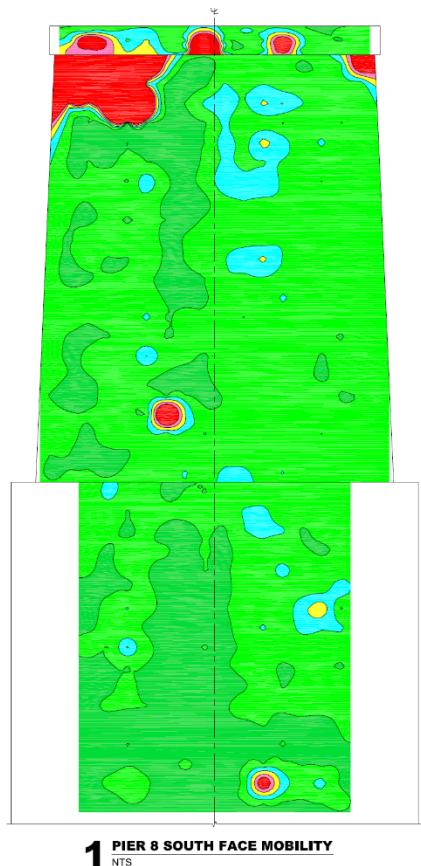
Figure 41. Photo. Impulse response test results

Testing of the exterior concrete was performed with Impulse Response (IR) testing and a Ground Penetrating Radar (GPR) survey. The IR testing allowed for complete mapping of areas with delaminations or substantially deteriorated concrete. The GPR survey allowed for mapping of the underlying rebar and the cover depth. The mapping of rebar was essential to avoiding damaging the reinforcement with cores taken from the faces of the piers. Coring of the pier faces was performed at 13 separate locations. During this evaluation, six 4-inch (100 mm) diameter cores were taken for compression testing, including from three of the four piers eventually reused. An additional eight cores from the faces of the piers were used for petrographic analysis. Figure 41 and Figure 42 illustrates impulse response results and core samples obtained during investigation, respectively figure 43(a) shows the drilling procedure through the deck and figure 43(b) shows drilling from a barge in the Ohio River.

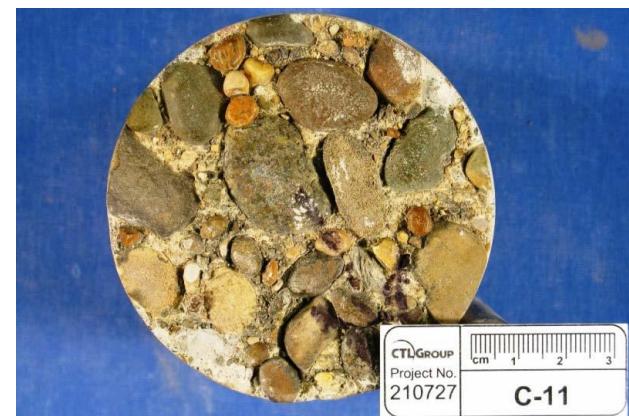
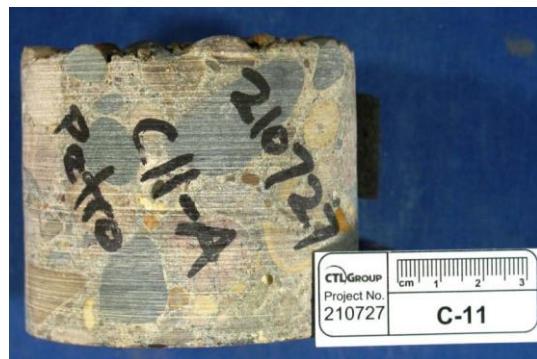
Figure 42. Photo. Cored samples

Concrete cores were extracted from both the faces of the concrete piers and from core holes drilled vertically through the deck, pier, and underlying rock. In all, 54 compression tests were performed on 2 in (50 mm) diameter cores removed from the vertical coreholes, and six compression tests were performed on 4 in (100 mm) diameter cores removed from the pier faces. The cores taken from the vertical coreholes had an average unconfined compressive strength of 9,250 psi (64.8 MPa), with a standard deviation of 1,780 psi (12.3 MPa). The test breaks for all the cores were generally above 6,000 psi (41.4 MPa), with 1 test breaking at 4,810 psi (33.2 MPa). The six 4 in (100 mm) cores had unconfined compressive strengths ranging from 7,000 psi (48.3 MPa) to 13,750 psi (94.8 MPa), with an average of 10,297 psi (71 MPa). Static modulus of elasticity testing was performed on two samples taken from the pier faces, which were found to have moduli of elasticity of 864,000 ksf (41.4 GPa) and 907,200 ksf (43.4 GPa). These values exceeded the material properties used in design, but ultimately the design modulus of elasticity was taken from the unconfined compressive strength. Table 19 summarizes the tests performed, issues evaluated, and extent of testing for this bridge.

A. Sample cross section

B. Sample elevation

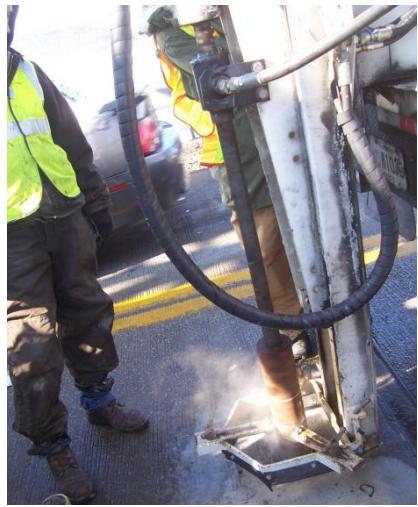
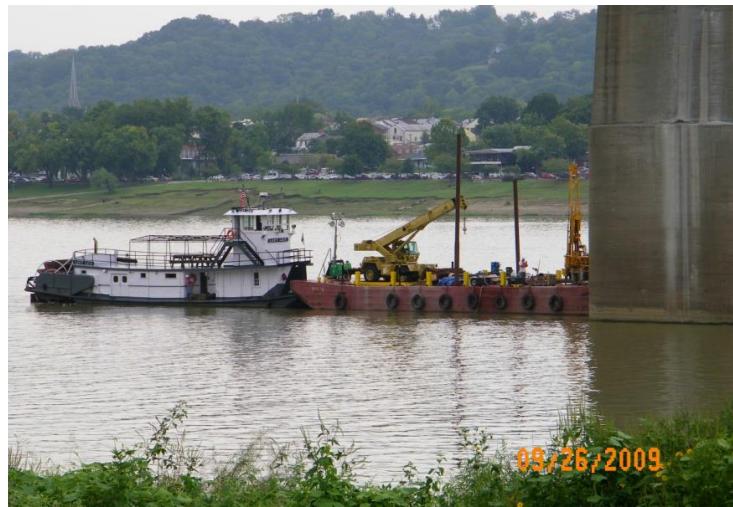
Figure 43. Photo. Drilling in Milton Madison Bridge

A. Through the deck

B. On the Ohio River

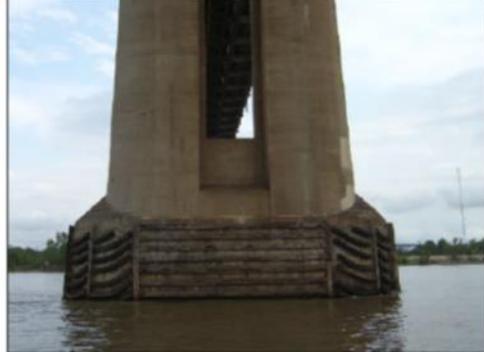
A diving inspection was performed to evaluate the condition of the pier below the water line. Due to the fast-moving currents and low visibility, the visual component of the diving inspection was of little use. Acoustic sonar imaging was performed to visualize the condition of the pier as well as the soil surrounding the pier. Examples of the images obtained through acoustic imaging are provided in figure 44.

A. North face with regular image

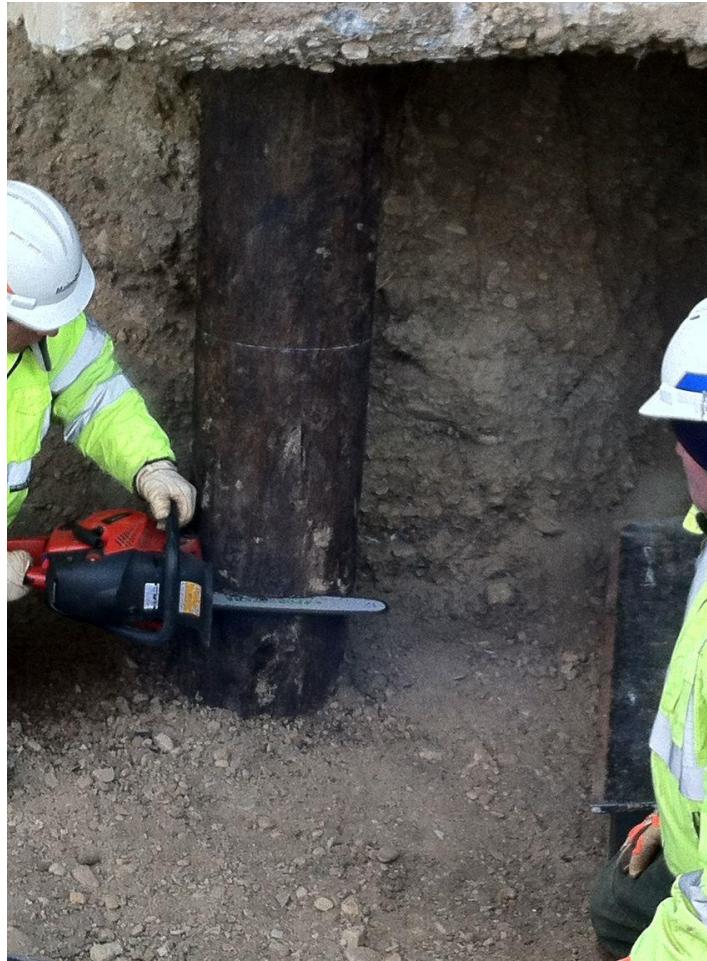
Figure 45. Photo. Excavation and removal of portion of timber piling at Haynesville Bridge

The condition of the timber piles was analyzed by exposing them through full excavation of the abutments. The upper most 20 in (51 cm) of the timber was sawed off, with the testers noting the presence of creosote during cutting. The exposed top of the remaining pile was then tested with a Pile Integrity Test (PIT) that consisted of striking the pile head with a hammer and waiting for a response. A pile integrity test was performed on a single pile from each abutment, finding that the piles had been driven to 26 ft (7.9 m) and 32 ft. (9.7 m). Figure 45 shows the excavated abutment with a pile being cut. Static load testing was then conducted on the piles exposed under the two abutments, as discussed in Chapter 6.

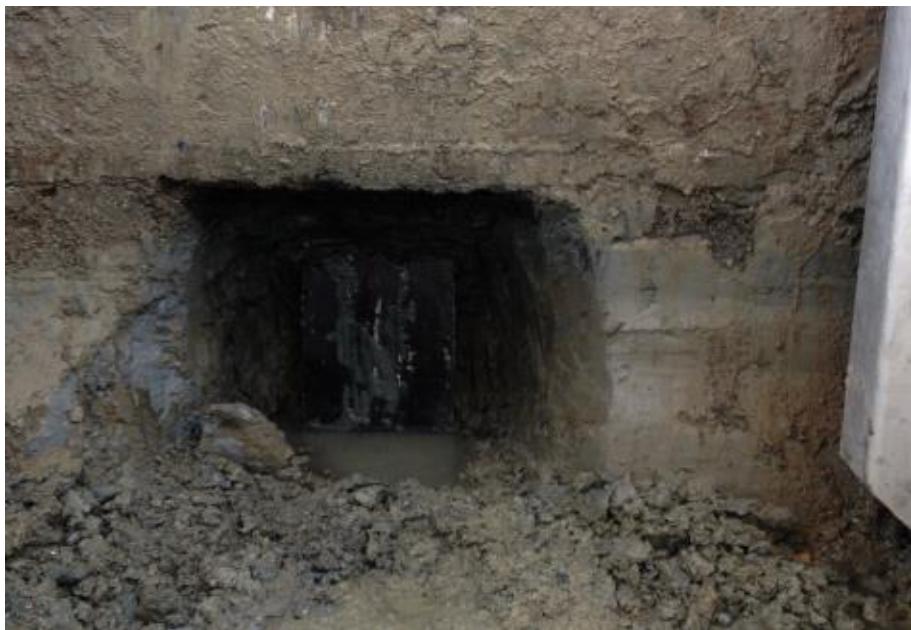
Figure 46. Photo. An exposed steel pile in a test pit

Overall, eleven piers and one abutment were supported by steel H-piles. Of these, deep test pits were excavated at four of the abutments to directly observe the steel piles (figure 46). In general, no corrosion was observed, except for a few spots with minor chipping or pitting. It was determined that in general, the water table remained above the bottom of pier cap for most piers, with some piers having the water level just reach the bottom of the pier cap. It was determined that corrosion was unlikely to have occurred on the steel piles, however a 1/16-inch (1.6 mm) reduction to the cross-sectional area of the pile was recommended to account for their extended service life.

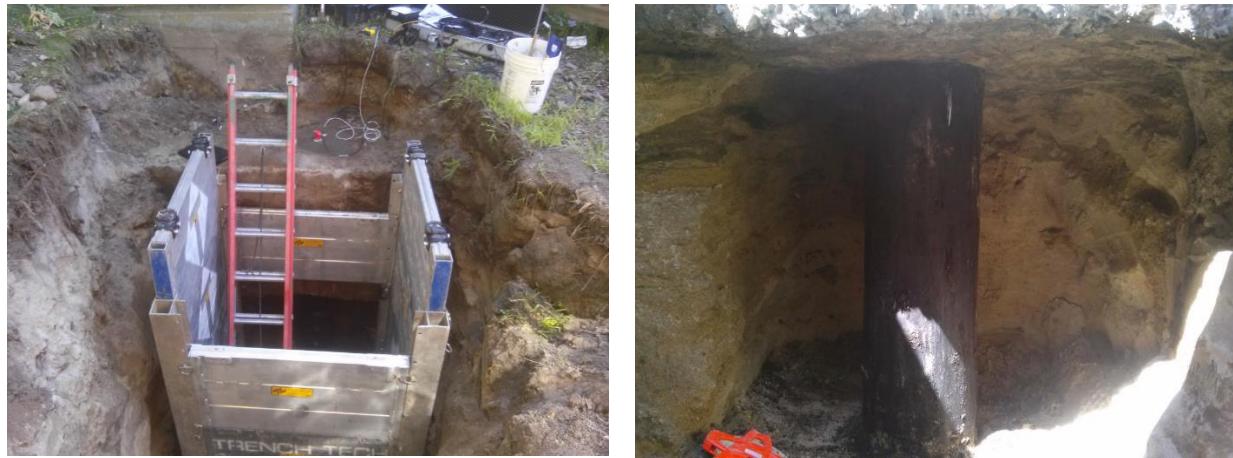
Figure 47. Photo. Integrity assessment of timber piles in Jackson Road over MA Route 2 Bridge

The integrity evaluation program consisted of four test pits (figure 47), one in each corner of the two abutments. The pile integrity of the timber piles was evaluated through visual inspection, coring, resistograph testing, and pulse echo testing. Visual inspection of the piles exposed in each test indicated that the piles were in good condition. Three 1/2-in (13-mm) core samples taken from a test pit pile at 8.5 in (21.6 cm), 18 in (46 cm), and 28 in (71 cm) below the pile cap. The core samples identified the preservative penetration depth (4.75 in (12 cm) for all cores), the depth of the pith, and a visual observation that no decay was present. Microscopic evaluation of the cores indicated that there was no fungal growth and identified the species of wood present. Resistograph testing was performed in 36 locations that supported the findings observed in the core-tested pile and ensured that the remaining piles did not have excessively weak zones. Pile integrity testing (pulse-echo) was performed to confirm that the pile length below grade and into the pile caps matched the documented lengths in the pile driving records. No major reflections that could indicate damage or voids were found from the pulse-echo data. Ground water was not encountered during any of the test pits, indicating that the water table was beneath the project site. Due to the observed good condition of the timber piles, it was assumed they would remain

A. Typical test pit setup with trench box

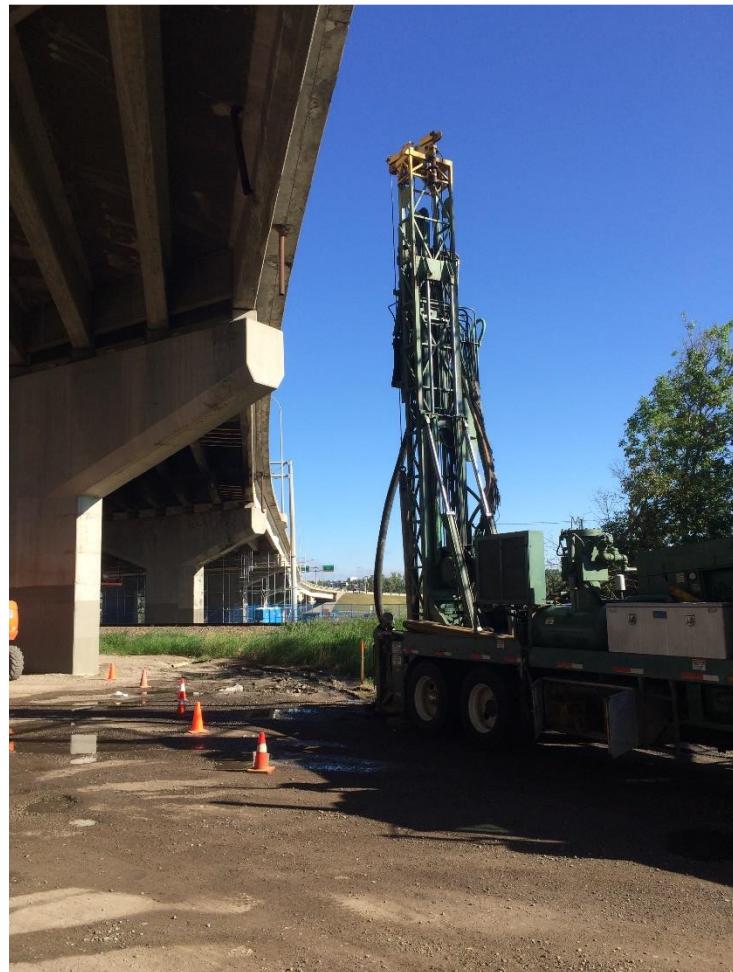
Figure 48. Photo. Drilling borehole for obtaining soil samples

The existing piers have displayed a history of “good” performance, used to justify the continued usage of the piers. As-built documentation for the existing piers is available and gives structural details on the pier geometry and material properties. The piers have not undergone any obvious deterioration that warrants additional material testing and analysis. The initial investigation for reuse of these piers therefore has focused determining the geotechnical conditions and capacity at the pier sites. Primarily, borings have been used to sample both the soil and rock, as well as verify the stratification of these layers. Testing has been performed on rock samples to quantify the strength and compressibility of the bedrock (figure 48). In addition to the boring and sampling program, a test pit was conducted on the riverine pier exposed during low-flow (Pier 1.) The test pit identified that the footing was in good condition, the pier had not suffered from previous scour, and the geometry match the as-built drawings.

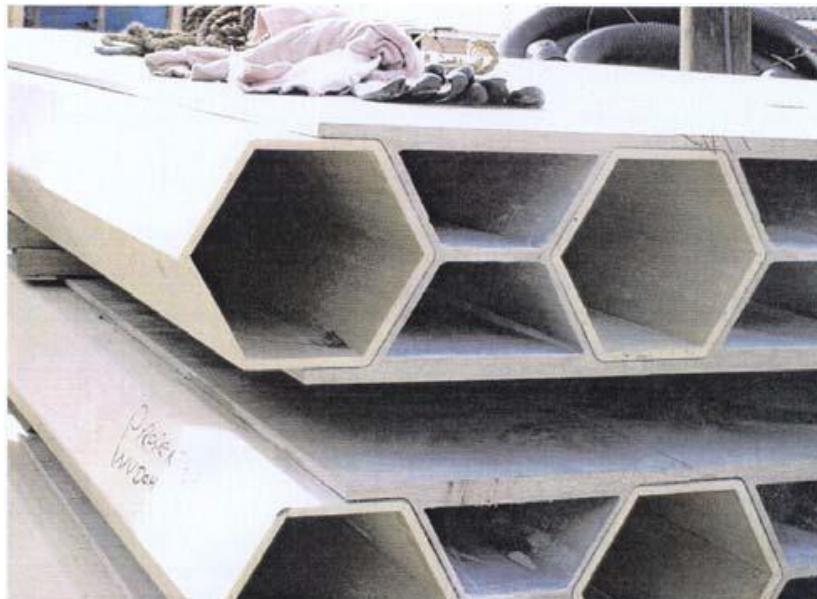
Figure 63. Photo. Honeycomb FRP deck used to replace concrete deck

elements or to eliminate the need for entire piers. An example of this approach is the Market Street Bridge in West Virginia, as documented by Gangarao et al. (2007). This bridge was a two-span continuous steel girder bridge with a composite concrete deck. The bridge was reconstructed with a honeycomb shaped fiber reinforced polymer (FRP) deck (figure 63) that was attached to the steel girders to allow for composite action. The FRP deck was able to replace some of the compressive contributions of the original concrete, but with a drastically lower mass. The existing center pier was abandoned in place, as the reduced dead loading allowed the two spans to be replaced as a single span. The existing abutments were also abandoned in place and new piles were driven behind the original abutments to allow for installation of new integral abutments. While not a reuse case, this system allowed for a variety of substructure alignments that would have not been possible with concrete deck.

One technique that has been explored is the use of composite FRP decks to reduce the weight of the superstructure (Gangarao et al. 2007; Whipp 2001). The FRP deck can act compositely with the original steel girders, replacing much of the strength of the concrete deck with a fraction of the mass. The reduction in mass can allow for drastically reduced loading on the substructure

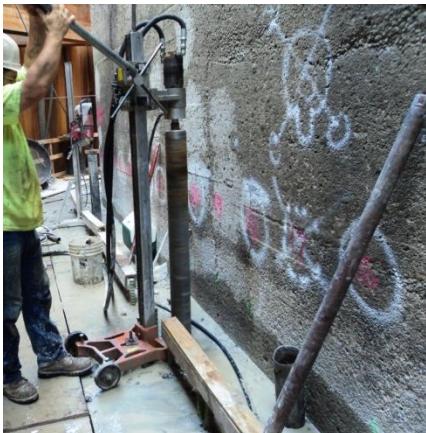
Figure 65. Photo. Coring of caisson concrete from inside of cofferdam

The caissons were cored with 4 inches (100 mm) diameter and 4-5/8 inches diameter holes (figure 65), and bundled #11 or bundled #14 bars were placed down the holes and grouted into place to act as tensile reinforcement (figure 66). The bars were extended up into the pier stem reinforcement to provide adequate load transfer capacity between the caisson and the pier stem. The caissons were analyzed as reinforced concrete columns using spColumn.

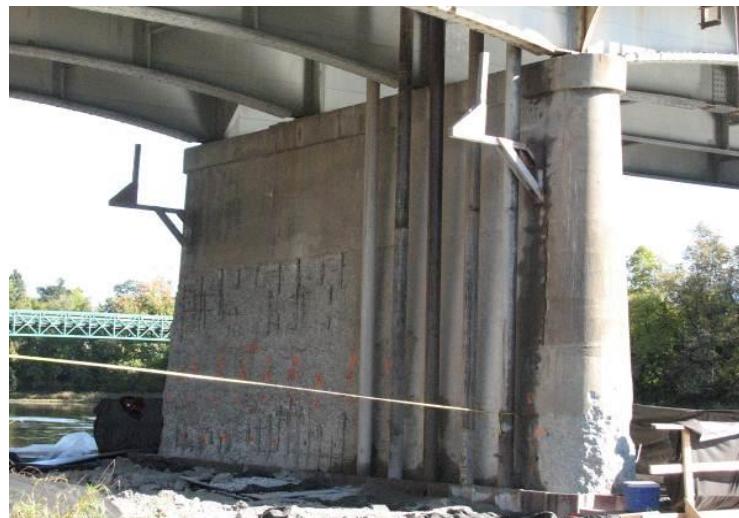
Figure 68. Photo. Micropile installation through bridge deck with casing down pier face

To minimize disruption to traffic, reduce the environmental impacts, and improve the constructability, alternative number five using micropiles was chosen. The micropiles were drilled directly from the bridge deck (see figure 68), by drilling through the deck concrete then through air until a ledge between the pier and cofferdam was reached. The micropiles were cased with permanent casing through the entire concrete footing and soil until 0.5m into bedrock. A total of twenty-four micropiles were installed at each pier. Figure 69 shows the micropiles being grouted during installation.

The micropiles were connected to the piers through a transfer structure that avoided the existing footings and transferred all foundation loads through the micropiles. The existing footings and sheet pile cofferdams were abandoned in place and the micropiles were directly connected to the lower portions of the piers. Twelve compressive struts made from steel rails were placed into each pier (figure 70). The struts were connected to the top of a micropile on each side of the pier and used to transfer the compressive loads into the micropiles. Threaded DYWIDAG bars were attached at the base of the pier to act as a longitudinal tie. Reinforced concrete was poured around the entire assembly to encase and protect the steel.
