# Protocols for the Assessment and Repair of Bridge Foundations

Final Report

August 2016  
FHWA HIF-17-044

U.S. Department of Transportation  
Federal Highway Administration

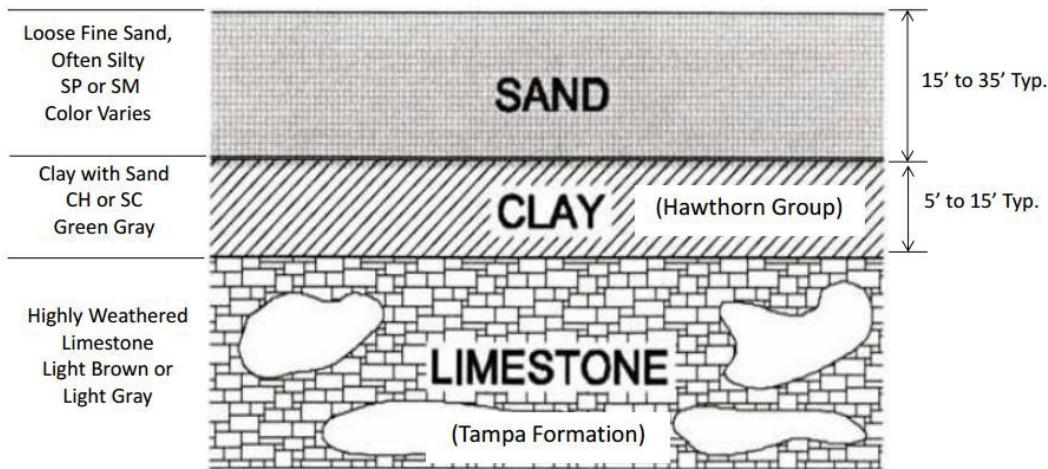
Figure A-9: Subsurface Conditions (Dapp et al., 2013)

Subsurface conditions consisted of 15 to 35 feet of recent sand and silt sediments underlain by 5 to 15 feet of marine clay and highly weathered limestone, as shown in Figure A-9. The geological conditions in this area consist of highly variable materials and strength and karstic limestone. (Dapp et al., 2013; Graham et al., 2014)

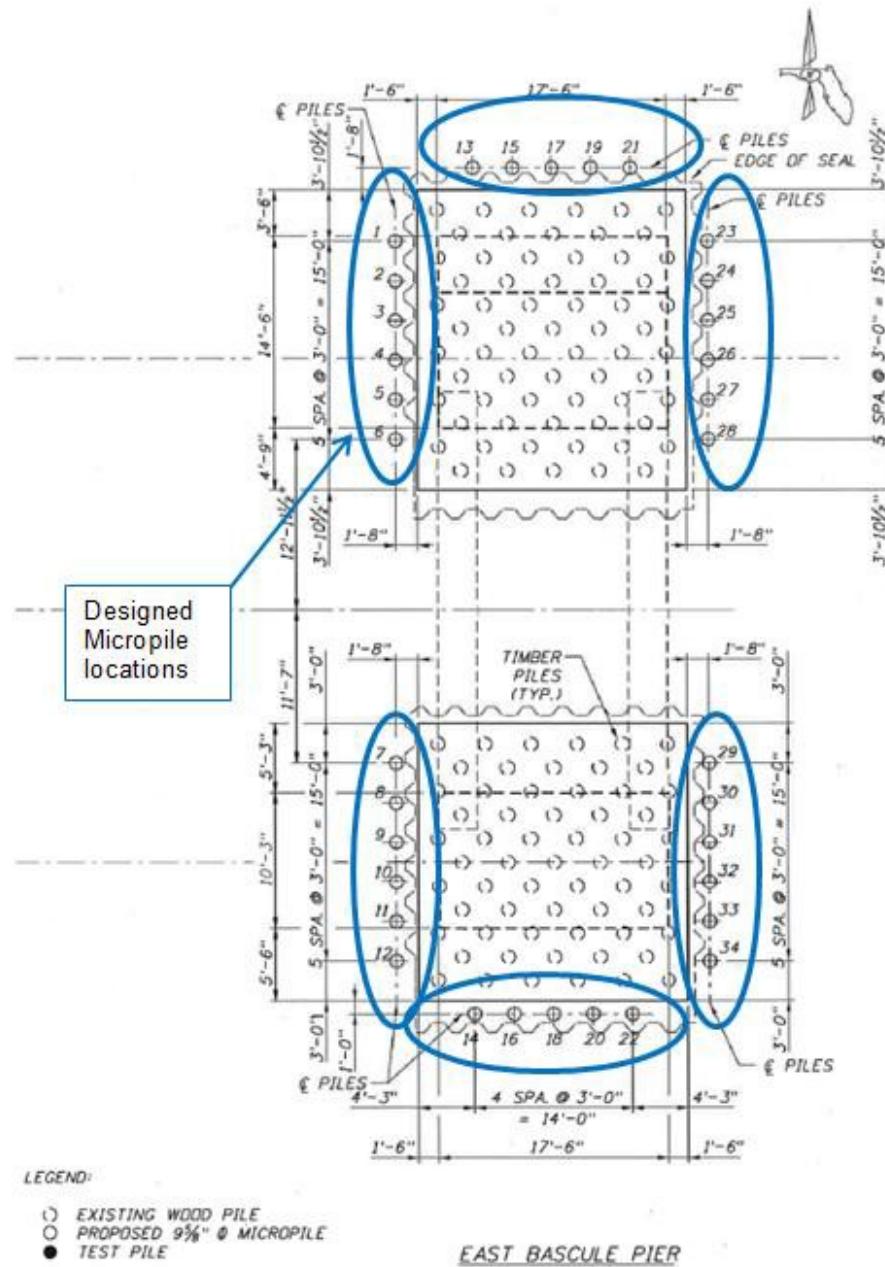
Figure A-12: Plan View of Micropile Locations for East Bascule Pier (Lauckner, 2013)

Options considered for foundation repairs and future settlement prevention included micropile underpinning and grouting of sand layers. It was also considered to change the construction phasing and details of the replacement bridge so that construction activities would be farther away from the existing bridge, but this was rejected due to substantial redesign efforts and schedule impacts that would occur. Micropiles were ultimately selected to underpin the bridge. Design consisted of 68 new micropiles installed to a depth of 80 feet, which was deeper than existing timber piles and construction activities of the new bridge. A plan view of designed micropile underpinning for one of the bascule piers is shown in Figure A-12. Dimensions of designed micropiles consisted of an outer diameter of 9.625 inches, a wall thickness of 0.472 inches, and a 35 foot bond length with a reinforcing bar. Micropiles were connected to existing footings with brackets. A design-bid-build contract was awarded to the lowest bidder to complete the repairs.

Construction and installation of new micropiles began in May, 2013 and were completed by November, 2013. The contractor earned a \$675,000 incentive bonus for finishing the work early. After repairs were completed and the bridge reopened, approximately  $\frac{1}{2}$  inch of additional settlements occurred as the new micropiles took on the full bridge loads and compressed. One complication and potential contribution to this settlement was that it was assumed construction would be in the dry with cofferdam groundwater cutoff; however, the contractor did the work underwater, making inspection and quality control difficult. This additional settlement did not cause the bridge to close again. (Kelly, 2013)

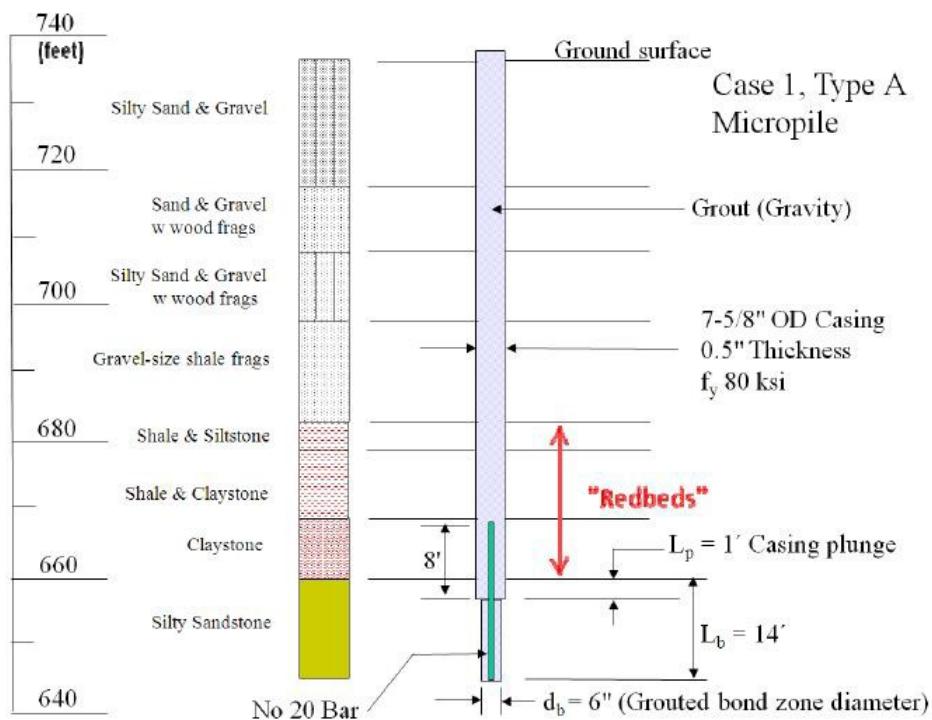
Figure A-13: Subsurface profile and test micropile dimensions (Splitstone et al., 2010)

The Birmingham Bridge in Pittsburgh, Pennsylvania carries 10,000 vehicles per day across the Monongahela River. The tied arch bridge was originally built in 1976. Piers were each supported by 48 steel H-piles. Original piles were driven to refusal, which was not always as deep as the design depth to rock due to intermittent layers of hard material and obstructions. Subsurface conditions, shown in Figure A-13, consist of approximately 30 to 40 feet of fill material underlain by layers of shale, claystone, and more competent sandstone. (Oakland Transportation Management Association, 2015; Splitstone et al., 2010)

On February 8, 2008, two spans of the bridge dropped 8 inches overnight. The bridge was closed once motorists called 911 to alert authorities about the movement. PennDOT immediately sent out 25 bridge inspectors to examine the entire bridge structure. A local general contractor and consulting engineer were brought in to analyze the superstructure and substructure and develop temporary supports. Movements were found to be due to steel rocker bearings at Pier 10S over rotating and failing, causing girders to drop onto the pier cap and damage the pier. Pier 10S had horizontal displacements up to 9 inches and cracking at the base of columns. Tiltmeters indicated that pier columns were bending and the pile cap had not rotated. Geotechnical investigations, including inductive coil testing of the two original driven piles, indicated that pile tip elevations

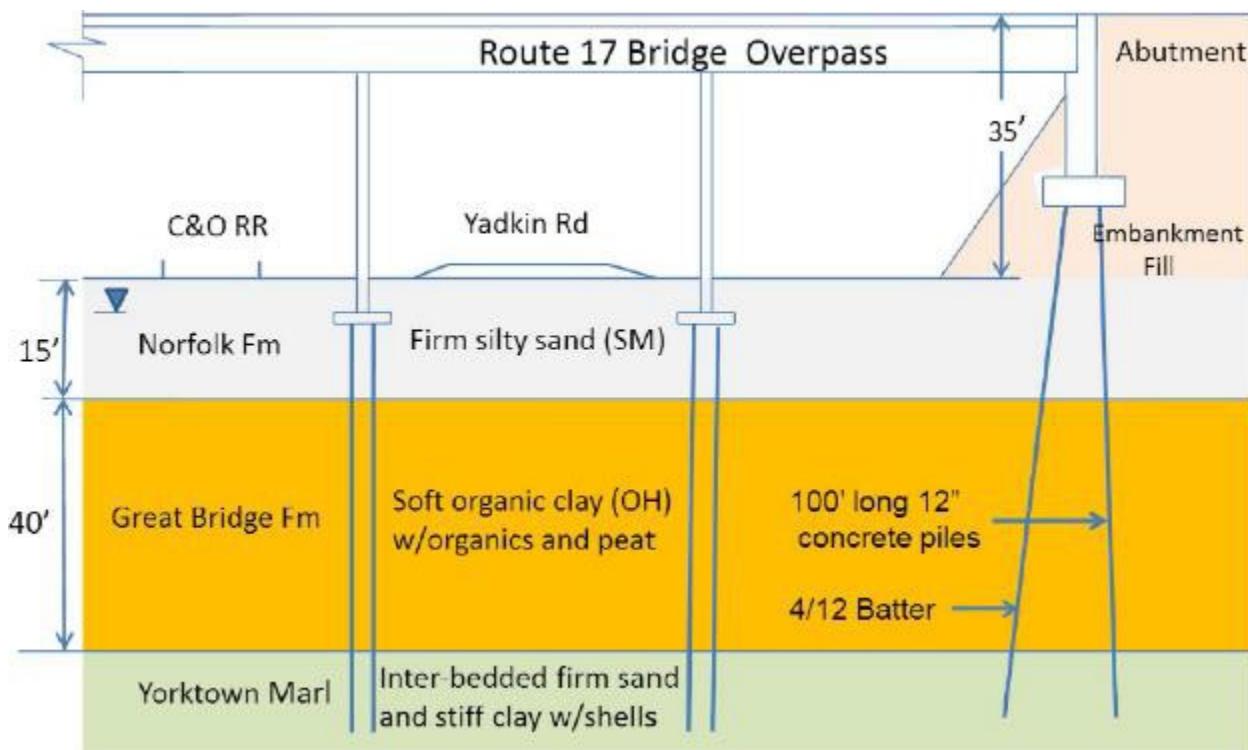
Figure A-15: Bridge Dimensions and Subsurface Conditions (DeStephen, 2015)

An overpass bridge carrying Route 17 in Chesapeake, Virginia was originally constructed in 1992. The 250-foot-long, 100 feet wide bridge was supported on 12 inch, pre-stressed, pre-cast concrete piles from 70 to 100 feet long. The approach embankments were 35 feet high and 90 feet wide on top. The subsurface conditions consisted of 15 feet of silty sand underlain by a 40-foot stratum of soft organic clay overlying firm sand and stiff clay. Figure A-15 shows original bridge dimensions and subsurface conditions. (DeStephen, 2015)

Settlements of 2.5 feet to 3.5 feet were expected from approach embankment loading during the original construction of the bridge. Since eighty percent of this settlement was expected to occur over 3 months, so the embankments were constructed and allowed to settle for 3 months before bridge construction began. However, by 2000, additional settlements of up to 2.5 to 3 feet had occurred at the approach embankments after the end of the bridge construction. Figure A-16 shows sagging of the approach at the surface from excessive embankment settlements. A study conducted in 2003 concluded that original analyses did not properly calculate anticipated settlements or account for downdrag effects on the foundation piles. Up to 22 more inches of consolidation of the soft clay layer under the existing embankment load was possible. Damage to the bridge from settlement included cracked beams, buckling of slope protection, and cracked wing walls. Investigation into the abutment foundations indicated that the piles supporting the abutment were severely damaged. Figure A-17 shows the tensile failure of a pile due to downdrag and the void beneath the abutment foundation. (DeStephen, 2015)

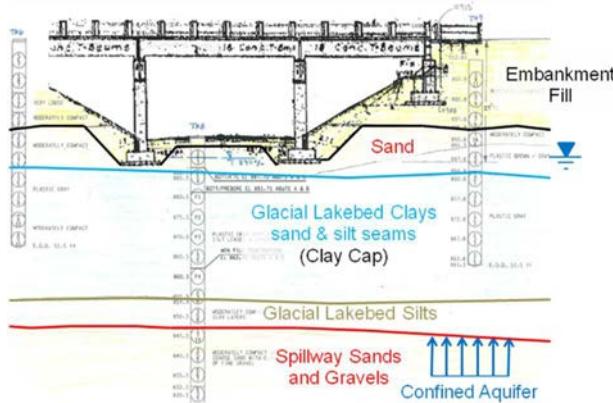
Figure A-19: General Soil and Groundwater Profile at Project Site (Thelen and Thome, 2011)

The Interstate 94 bridges over Riverside Drive were originally completed in 1958 as three-span, simply supported structures with continuous partial-height abutment walls and isolated piers supported by shallow foundations (Thelen and Thome, 2011). The geologic section was characterized by a relatively thick glacial lake bed deposit, which formed a confining layer of clay over glacial spillway sands and gravels, which were under a “near artesian” piezometric head. Typical subsurface conditions are depicted by Figure A-19.

Plans for replacement bridges were based on single-span, simply supported structures with continuous full-height abutments supported by deep foundations consisting of HP12x53 piles. Construction of the replacement bridges was to be in partial-width stages so as to maintain traffic in both directions. However, during the initial construction stage, movements were significant enough to require temporary closures and emergency stabilization of the bridges.
