Rapid Stabilization of Thawing Soils for Enhanced Vehicle Mobility

A Field Demonstration Project

Maureen A. Kestler, Sally A. Shoop, Karen S. Henry,
Jeffrey A. Stark, and Rosa T. Affleck

February 1999

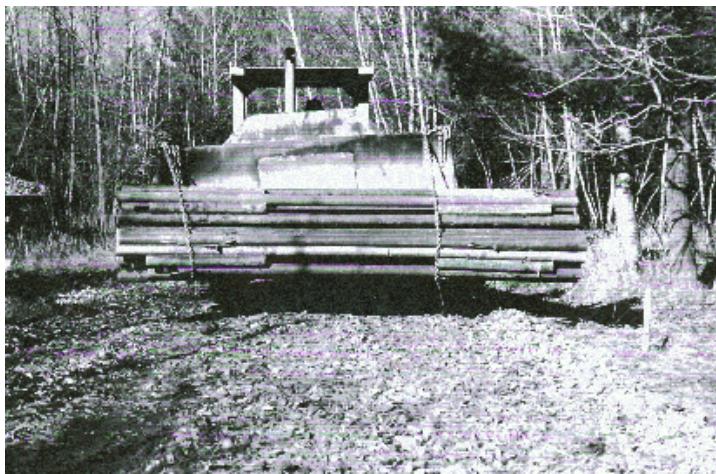
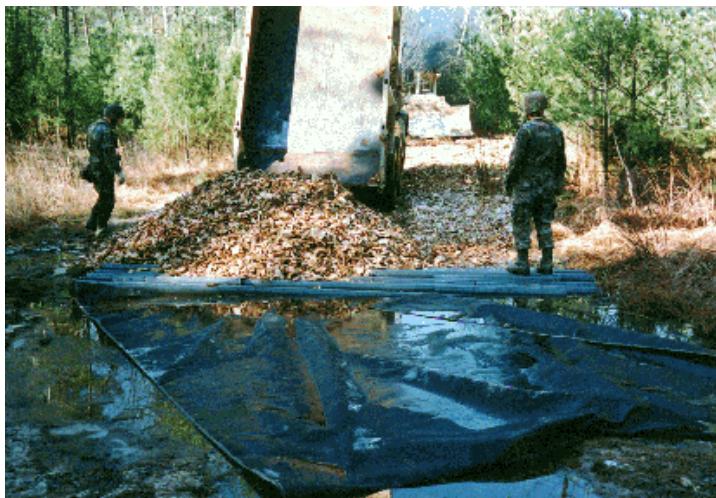
Figure 6. PVC fascine.

a. Fascine.

b. Covered with chunkwood.

A fascine is a series of parallel pipes placed to fill a ditch that allows traffic to travel across (Fig. 6a). In contrast to a typical military fascine, the fascine mats used for this demonstration project were constructed of materials similar to those used by the USFS (Mason 1990), e.g., 6-m-(20-ft-) long schedule 80 PVC pipe, 1.6 cm (5/8 in.) steel cable and cable clamps. Two 4.6-m-(15-ft-) long by 4.9-m- (16-ft-) wide fascines were constructed.

prior to the demonstration. Water, approximately 10–20 cm (4–8 in.) deep, was flowing across the trail. By use of a D7 bulldozer, the fascine was moved into place, placed on top of a geotextile, and covered with chunkwood.

The second location was another area where water was flowing across the trail. The HEMTT was used to transport the fascine to this test section. The fascine was unrolled so it was only one pipe thick (Fig. 6), and covered with tire mats.

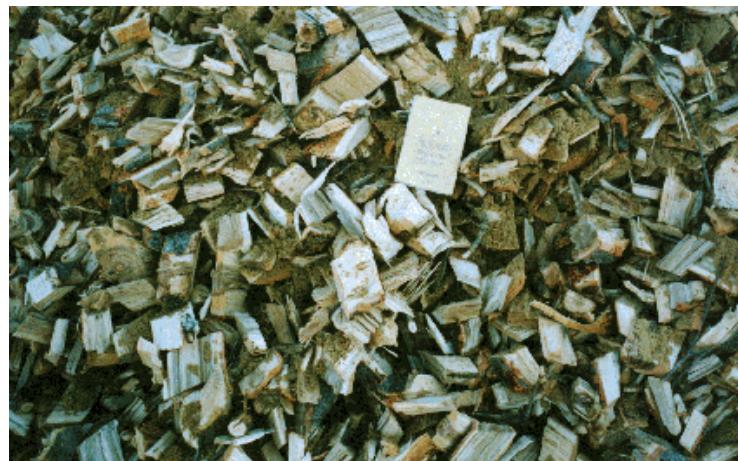
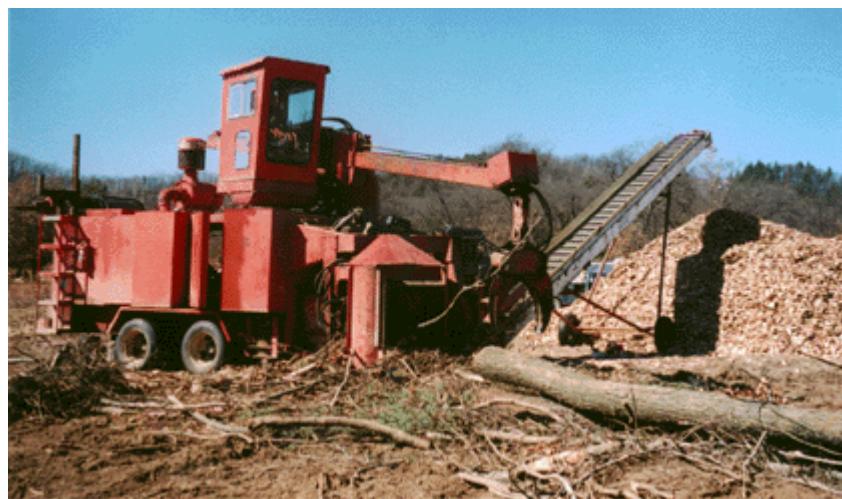
Figure 8. Chunkwood.

a. Chunkwood fill.

b. USDA Forest Service wood chunker.

The chunkwood was produced by shredding whole trees with a USFS prototype wood chunking machine. The resulting wood chunks were approximately 3.8 cm (1.5 in.) thick and were well graded, ranging from 1 to 20 cm (0.5 to 8 in.) in diameter. The chunkwood was mixed with sand in the approximate ratio of three parts chunkwood to one part sand. The density of the chunkwood/sand mix was approximately 796 kg/m^3 (50 lb/ft³). The bulking factor appeared to be low. Although testing by the USFS has shown a sheepsfoot or padfoot roller improves compaction, the chunkwood compacted easily with construction vehicle traffic. The compacted surface was relatively smooth and provided a good wear surface (Fig. 8).

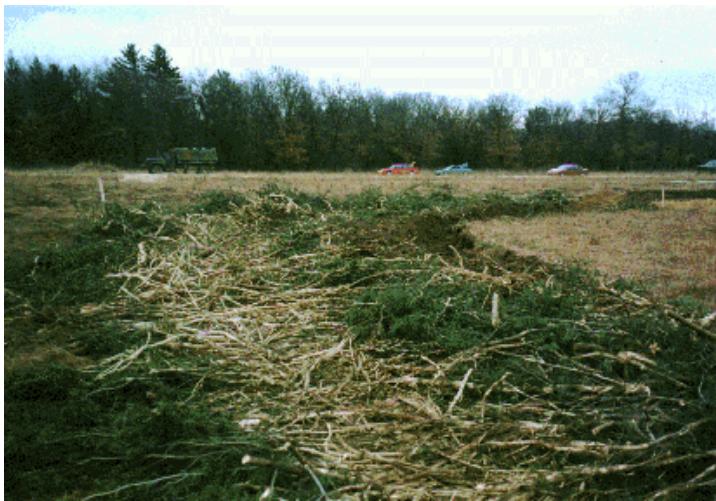
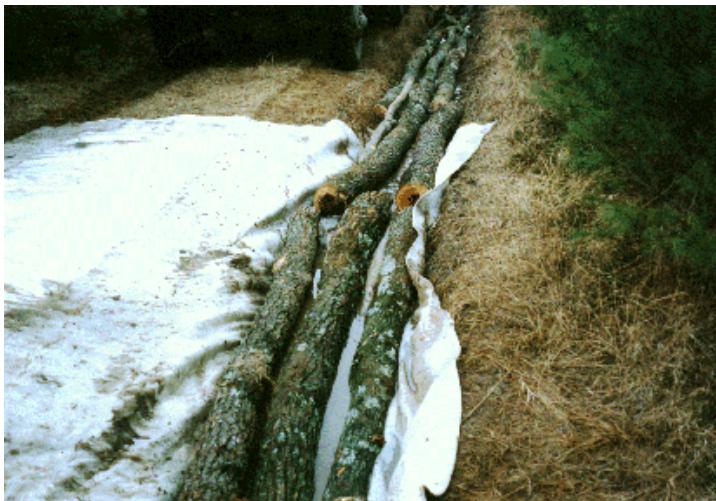
Figure 9. Slash.

Figure 9a. Slash—pentagonal loop trail.

b. Larger diameter logs used to fill large rut.

The slash test section on the wooded trail was 30 m (100 ft) long; the southern 15 m (50 ft) was covered with a geotextile before construction began. There was a large rut in the easterly wheel path in the slash test section. This rut was filled with logs (approx. 15 cm [6 in.] in diam.), running parallel to the rut (Fig. 9b). It took about five rows of logs to fill the rut. Next the slash was delivered. In this test section, the maximum diameter slash allowed was 8 cm (3 in.). The first few truckloads had trees that were larger than 8 cm (3 in.) in diameter. These trees were delivered to the site, cut up on site, and placed. The remaining trucks

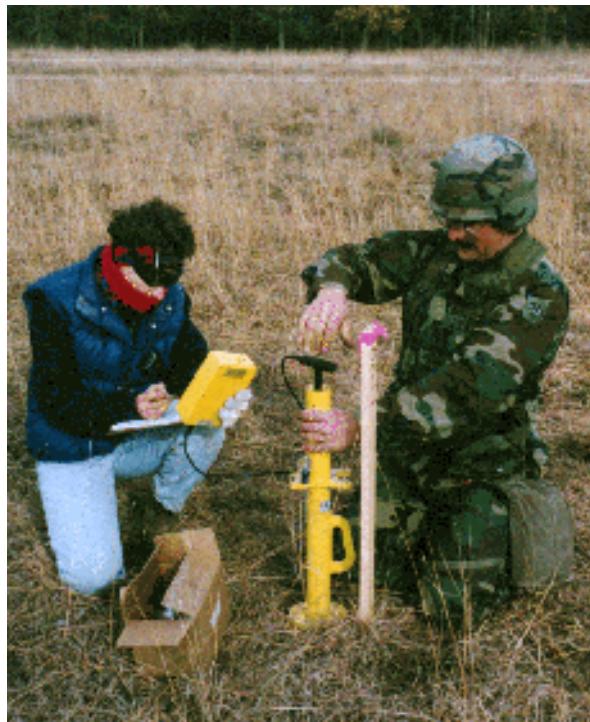
b. Clegg impact tester (CIT).

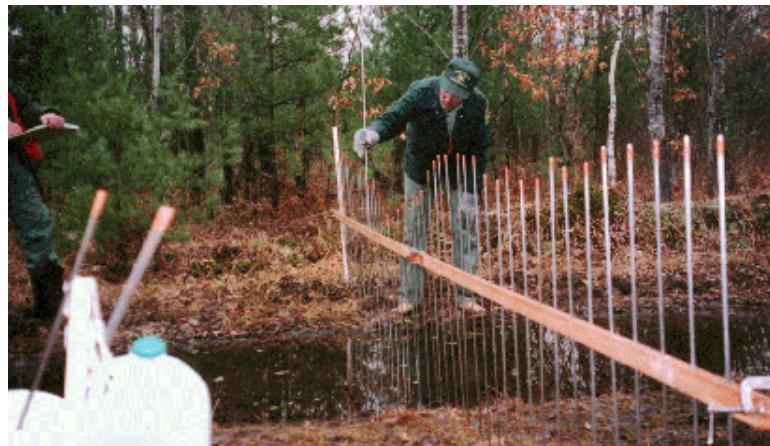
c. Measuring rut depths manually.

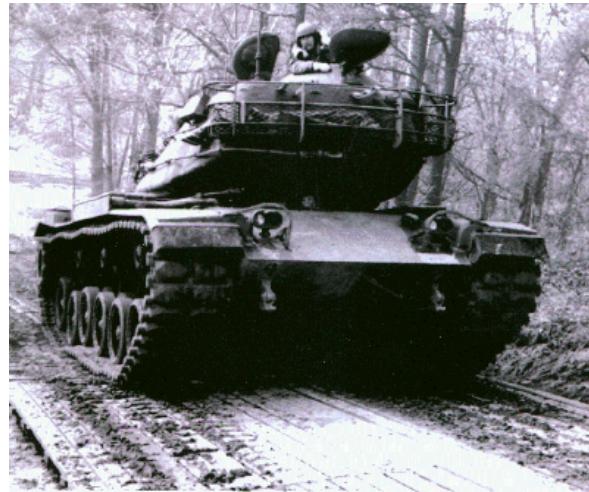
Specifications for the M60A3 Tank	
Crew	4
Combat weight	51,500 kg
Unloaded weight	47,500 kg
Power-to-weight ratio	14.56 bhp/tonne
Ground pressure	0.85 kg/cm ²
Length gun forwards	9.436 m
Length hull	6.946 m
Width	3.631 m
Height	3.27 m
Firing height	2.095 m
Ground clearance	0.45 m
Track	2.921 m
Track width	711 mm
Track adjustment	Hydraulic
Track type	T142 replaceable pads
Length of track on ground	4.235 m
Max road speed	48.28 km/h
Fuel capacity	1420 liters
Max road range	480 km
Fording	1.22 m
Fording with preparation	2.4 m
Gradient	60%
Side slope	30%
Vertical obstacle	0.914 m
Trench	2.59 m
Engine	AVDS-1790-2D
Suspension	Torsion bar

a. *M60A1 Tank.*

Figure G1. Vehicles used for trafficking Fort McCoy test sections.
